**APPEALS AND REVIEWS COMMITTEE**

This meeting will be recorded and the sound recording subsequently made available via the Council's website: [charnwood.gov.uk/pages/committees](http://charnwood.gov.uk/pages/committees)

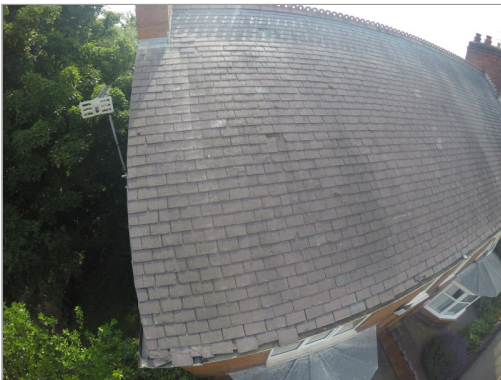
*Photo - 5 Front pitch with numerous slipped slates.*

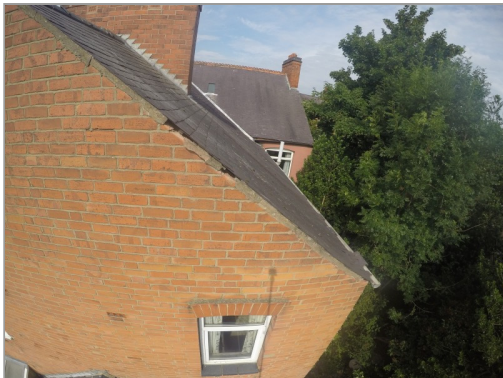
Photo - 9 Loose verge pointing

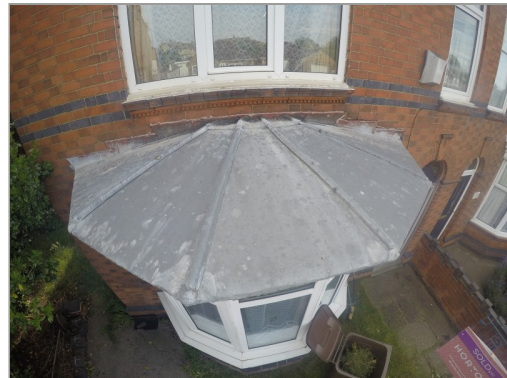
Photo - 10 Bay roof. Note loose flashings. This might explain water staining to ceiling in front reception

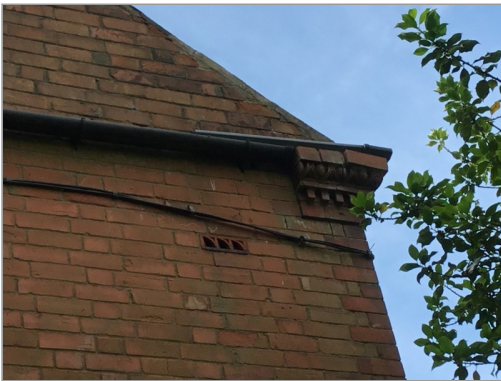
Photo - 11 Poor connections

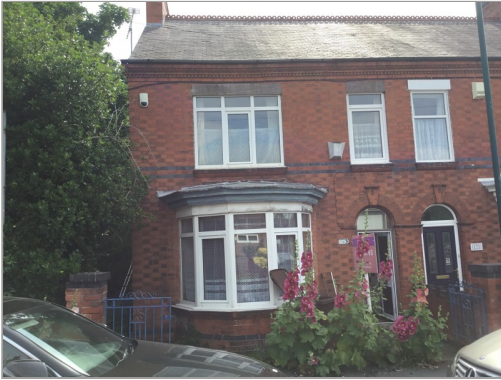
Photo - 12 Front elevation

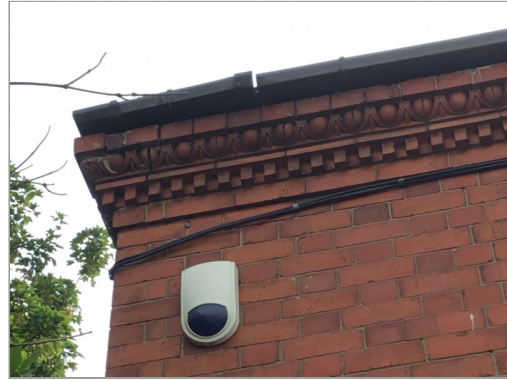
Photo - 13 Loose bricks beneath disconnected gutter in front left corner.

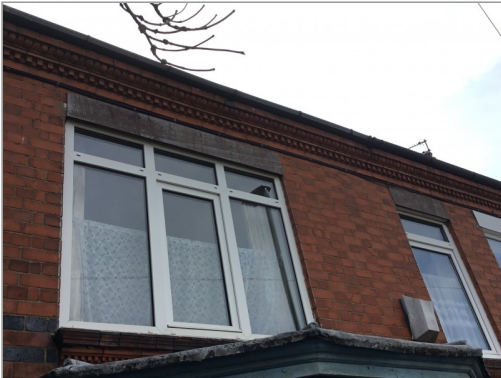
Photo - 14 Timber cladding over lintels to front elevation

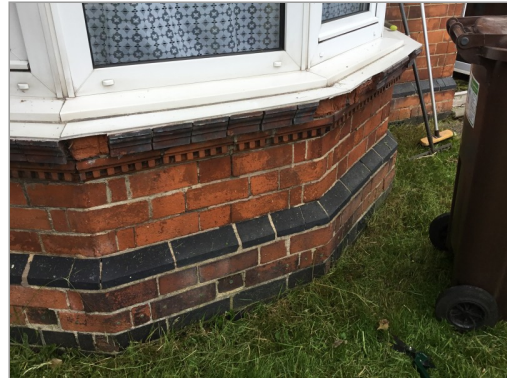
Photo - 15 Damaged bricks beneath front bay. Also note injected DPC

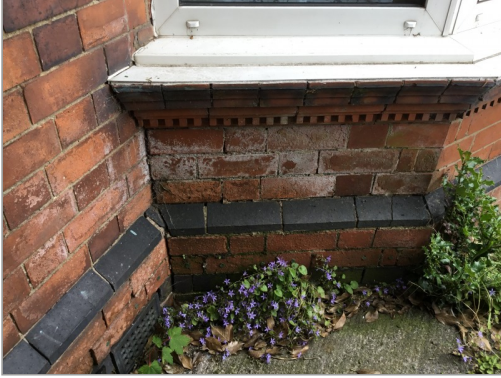
Photo - 16 Spalled bricks and weathered mortar

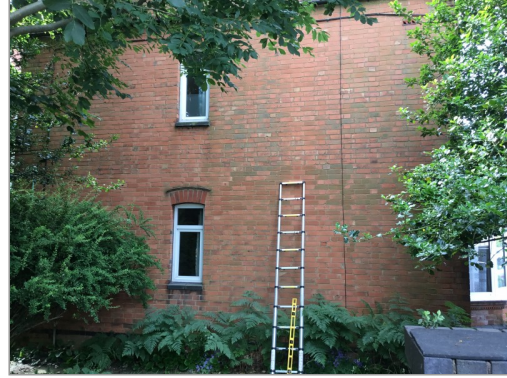
Photo - 17 Left elevation

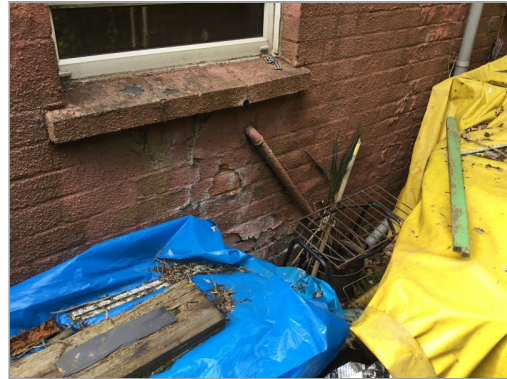
Photo - 19 Textured coating in poor condition

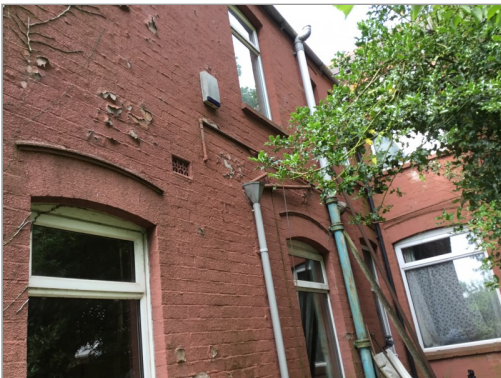
Photo - 20 Rear projection

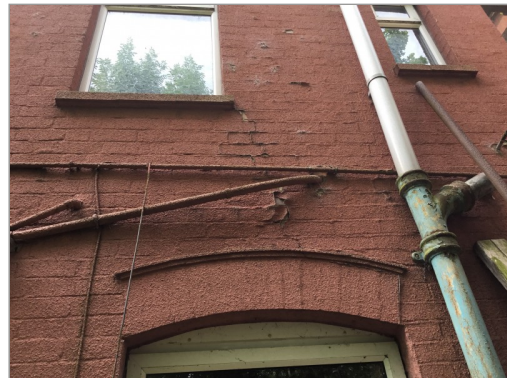
Photo - 21 Cracking apparent over rear projection

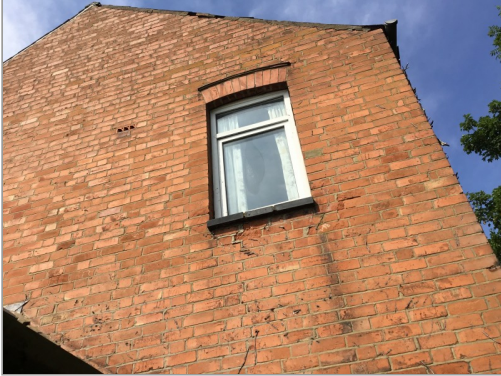
Photo - 22 Cracking to rear elevation

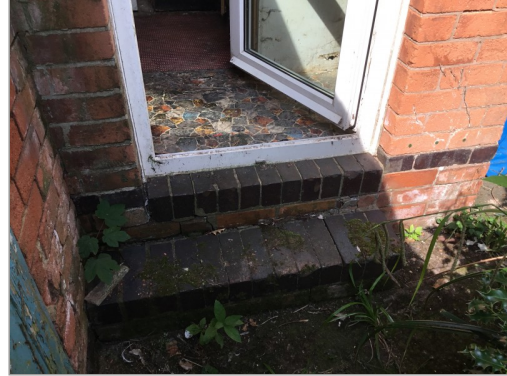
Photo - 23 Cracking beneath back door on rear elevation

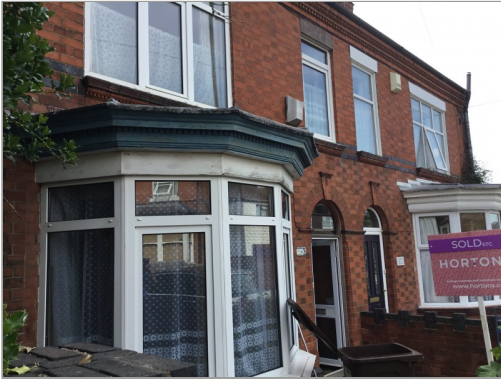
Photo - 24 Front windows

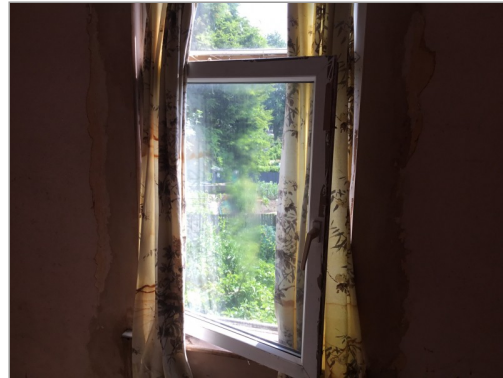
Photo - 27 Handle and lock broken on fire escape window in back bedroom

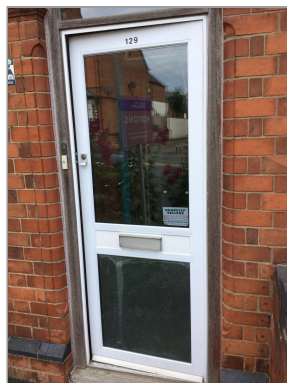
Photo - 30 Front door

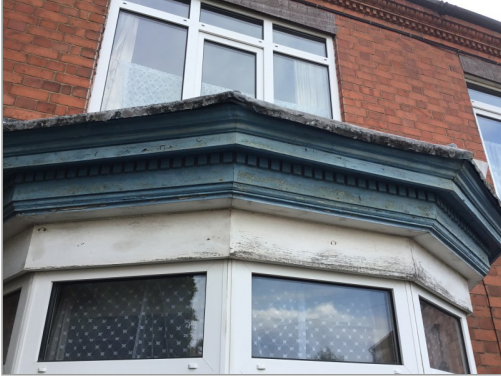
Photo - 33 Fascias in poor decorative condition

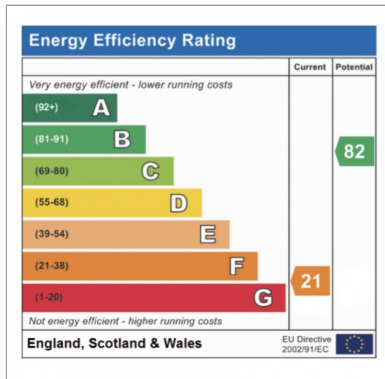
Photo - 34 Energy Efficiency Rating

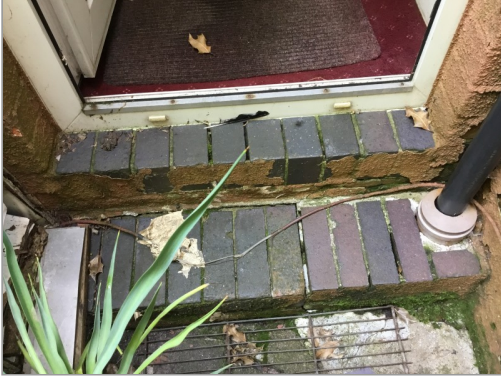
*Photo - 36 Loose steps to side door*

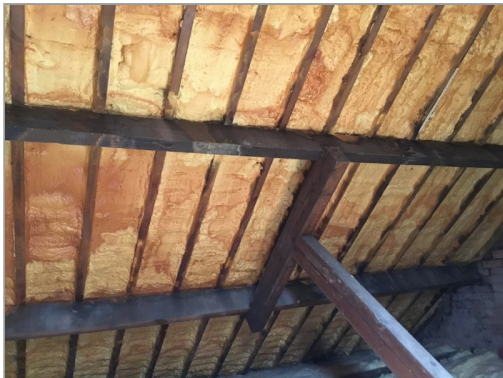
Photo - 37 Foam applied to underside of slates.

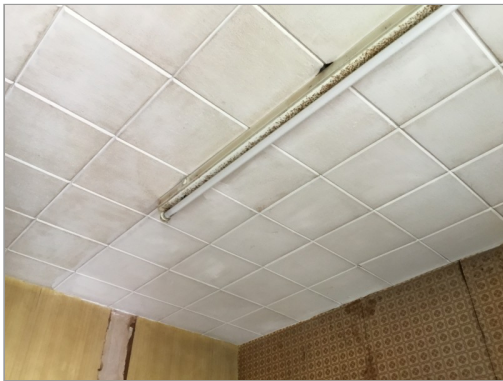
*Photo - 43 Polystyrene tiles*

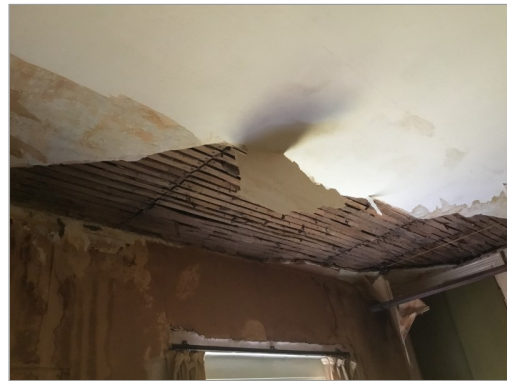
*Photo - 44 Damaged ceiling in rear reception*

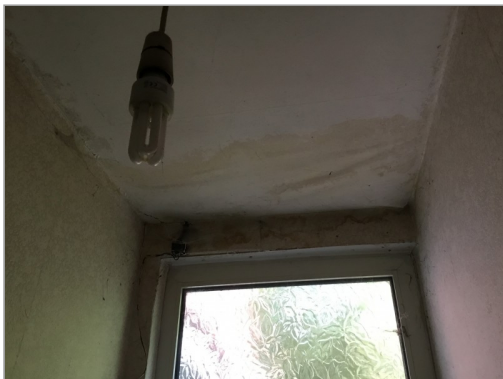
*Photo - 45 Water staining over side door*

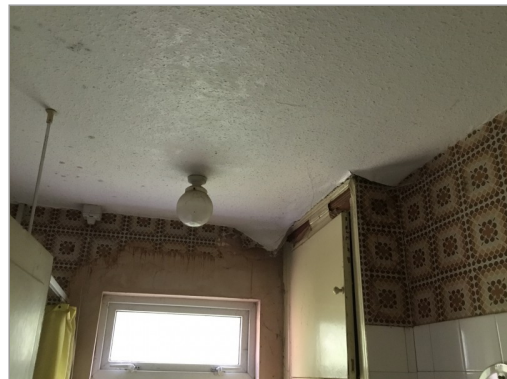
*Photo - 46 Bathroom ceiling*

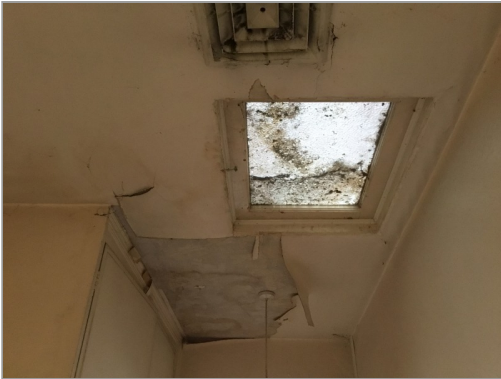
*Photo - 49 Damage around loft hatch on landing*

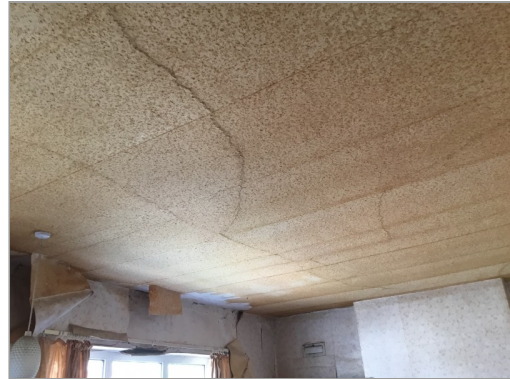
*Photo - 50 Front bedroom*

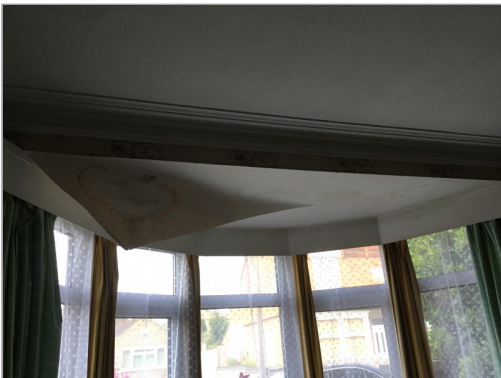
*Photo - 51 Water damage to bay ceiling*

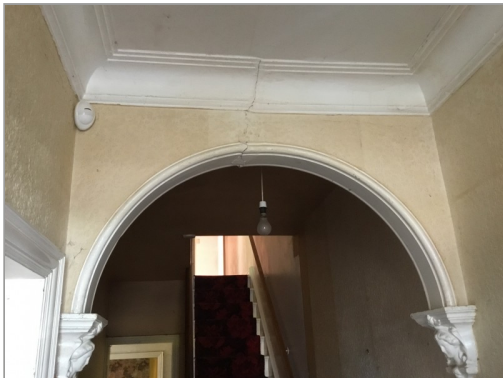
Photo - 52 Cracking in hallway

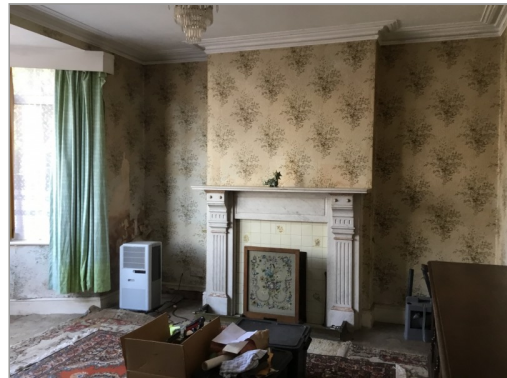
Photo - 53 Front reception

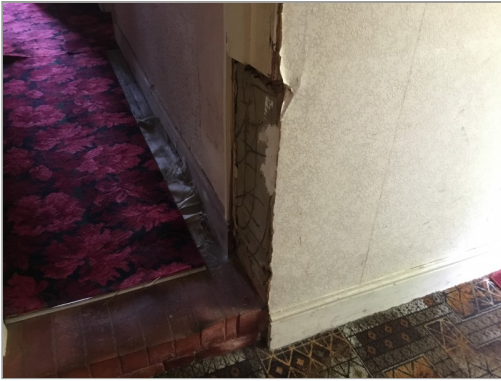
Photo - 56 Section of doorframe missing and wall repaired beneath

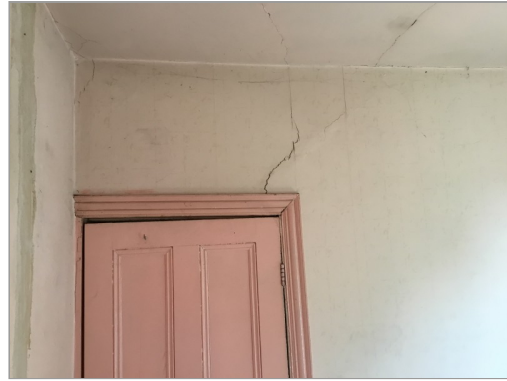
Photo - 57 Distortion in back bedroom door frame suggests historic movement toward the left elevation has occurred.

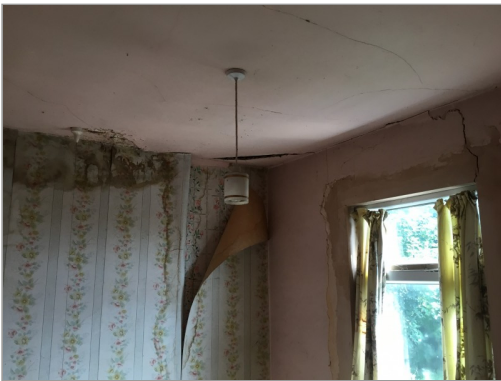
Photo - 58 Damage in back bedroom most likely due to roof leak and also cracking on rear elevation (see section E4)

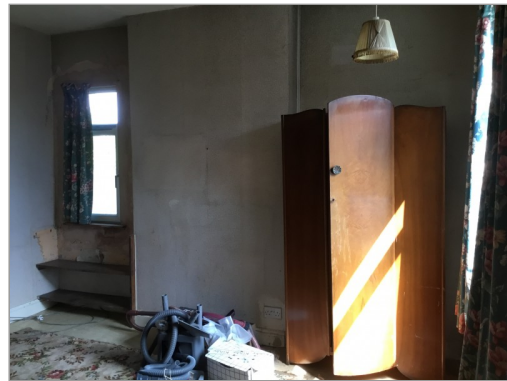
Photo - 59 Middle bedroom

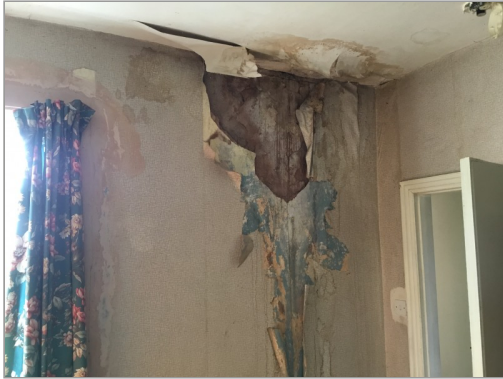
Photo - 60 Damaged middle bedroom due to leak in roof

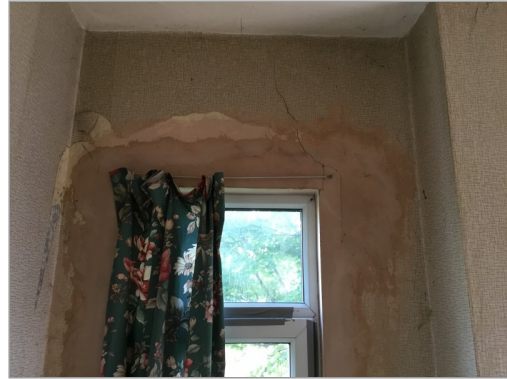
Photo - 61 Cracking in middle bedroom likely due to absence of lintel

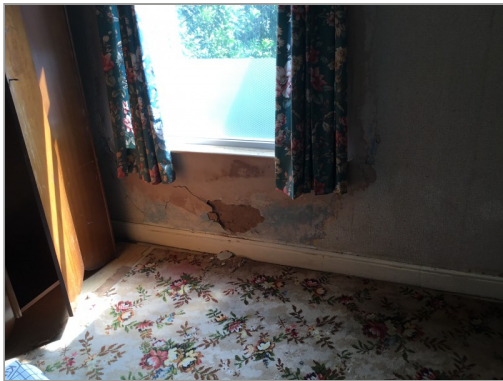
Photo - 62 Rear wall in middle bedroom

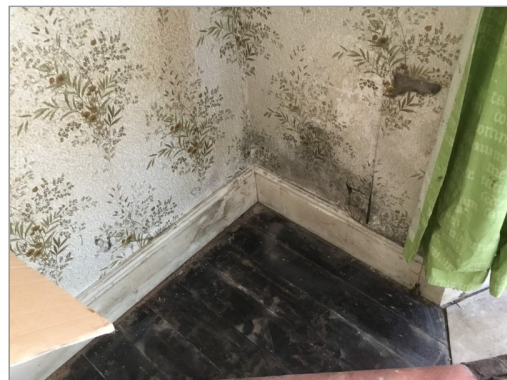
Photo - 65 High moisture content and crumbling plaster in front reception

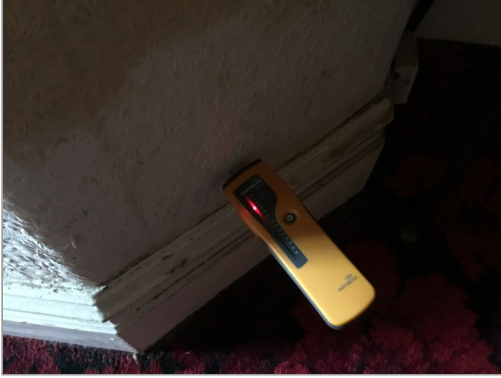
Photo - 66 High moisture content in hallway

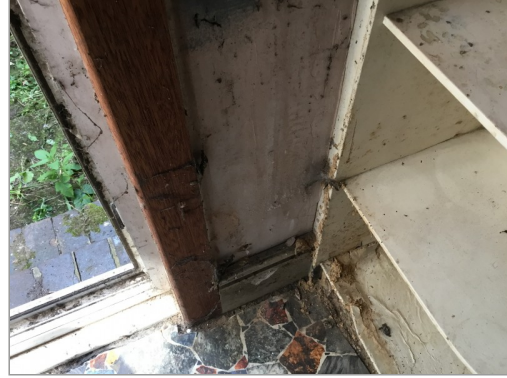
Photo - 67 Crumbling plaster and high moisture content in kitchen by door

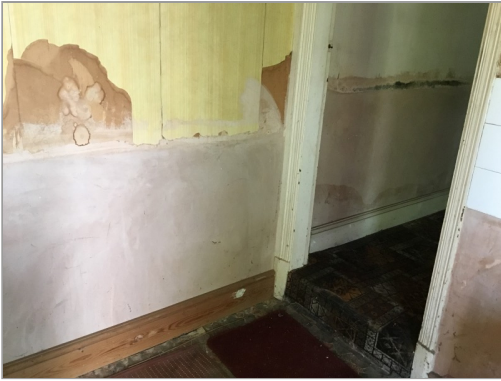
Photo - 68 High moisture content in party wall despite it being a newer plaster. Note "tide mark" in rear reception

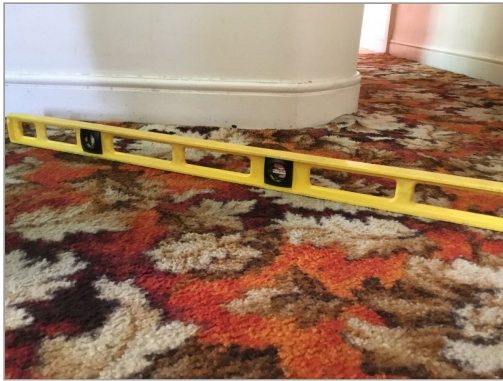
Photo - 69 Slight slope in landing floor

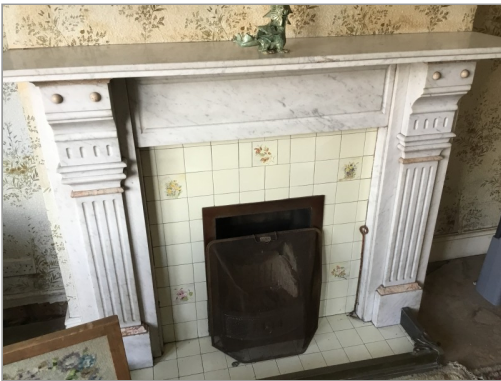
Photo - 72 Front reception

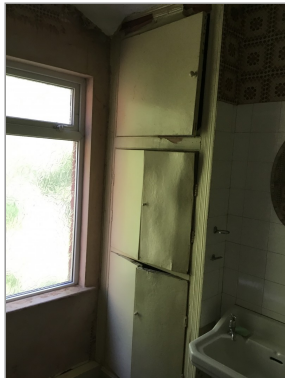
Photo - 77 Bathroom cupboard

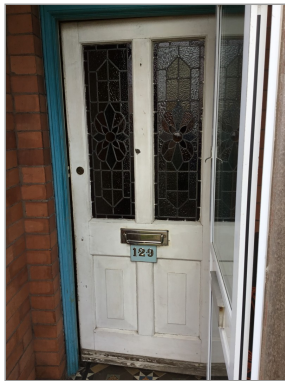
Photo - 80 Inner front door of dated design with no safety glass

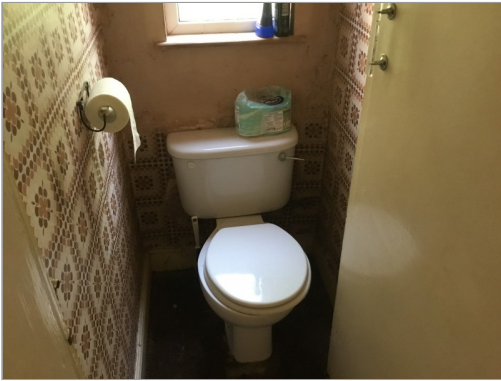
The kitchen fittings are very dated and we would recommend that you obtain a quotation for their replacement prior to exchange of contracts. Condition Rating 3

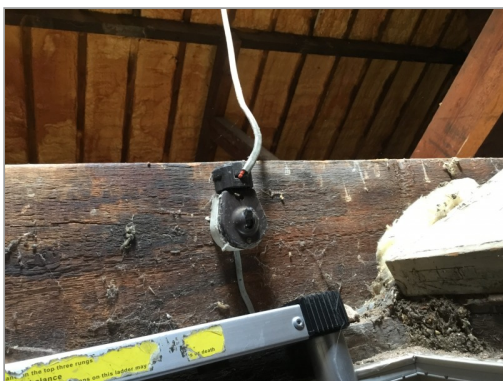
Photo - 86 Dated electrics

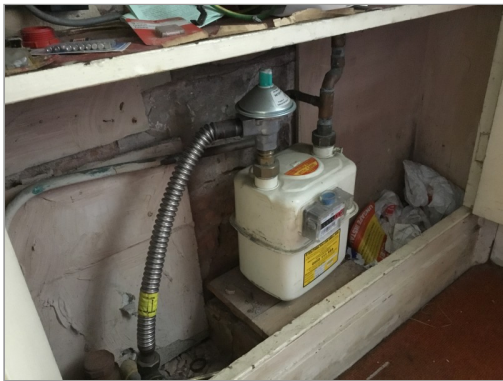
If a recent test certificate, dated within the last 12 months, is not available for the gas supply and appliance(s) then we recommend they are tested. See Sections I2 - Guarantees and J3 – Risks to People.

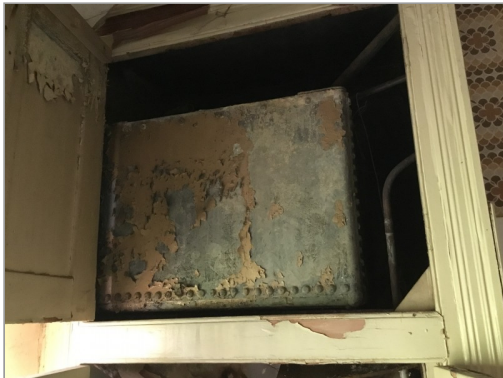
Photo - 89 Water tank

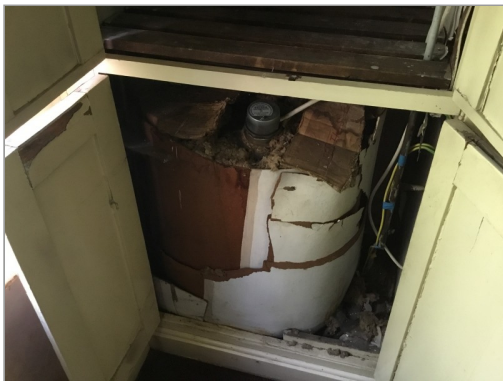
You should instruct a competent contractor to carry out an inspection of the hot water cylinder and carry out repairs or replacement as appropriate. (See Section J - Risks).

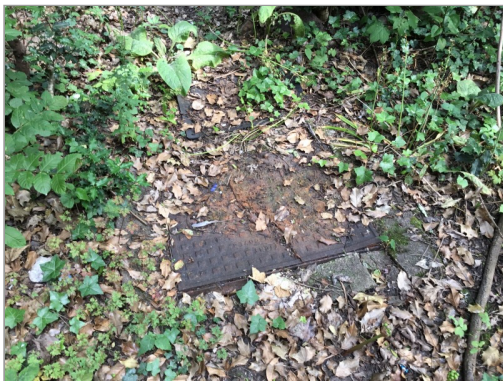
Photo - 93 Unable lift lid as it is broken

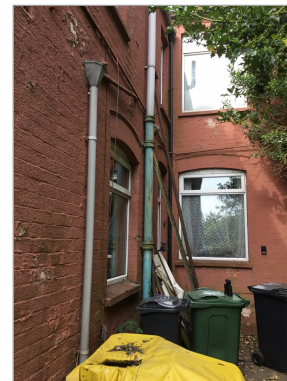
Photo - 94 Lower cast iron soil and vent pipe in poor condition

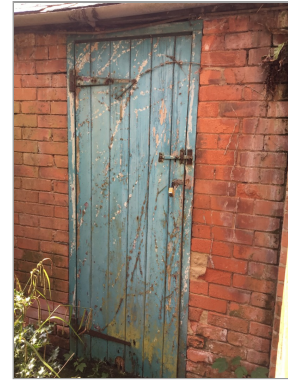
Photo - 99 Door and frame in poor condition

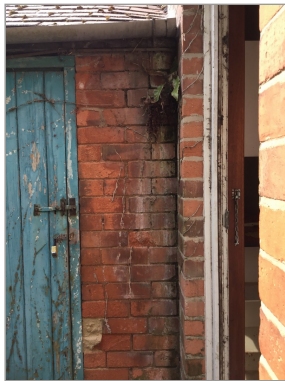
Photo - 100 Spalled and stained bricks from leaking gutter

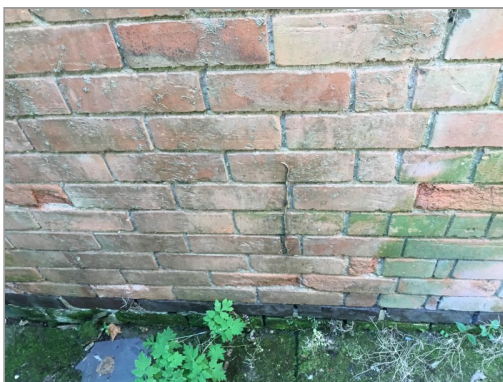
Photo - 104 Spalled and weathered bricks

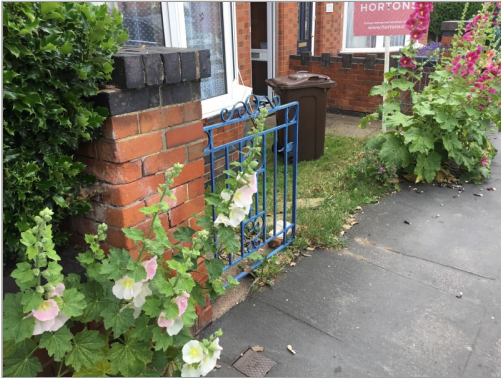
*Photo - 106 Boundary wall in poor condition with sections missing*

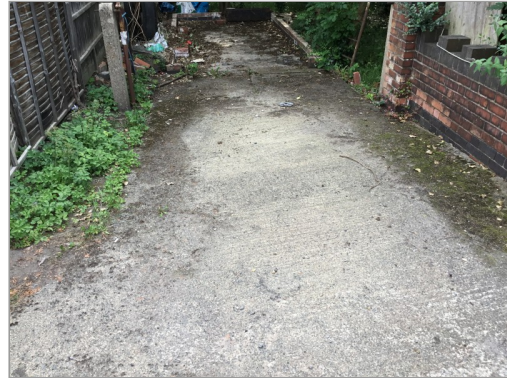
*Photo - 107 Driveway cracked and in poor condition*

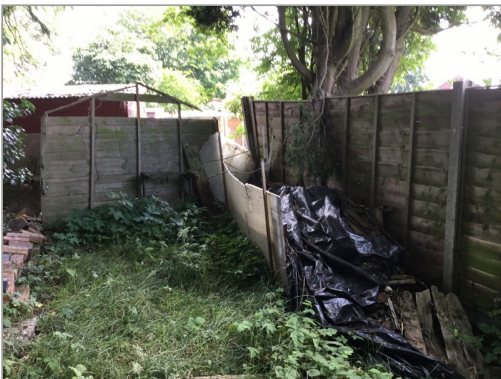
*Photo - 108 Fences in poor condition*

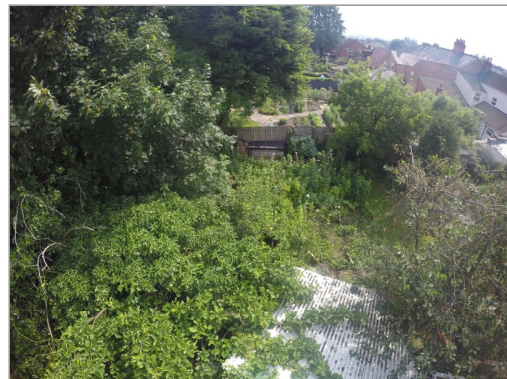
*Photo - 109 Back garden*

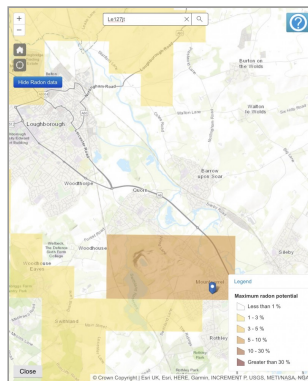
Photo - 111 Radon data map
