Alan Moss Road Phase 1 (Left HS)

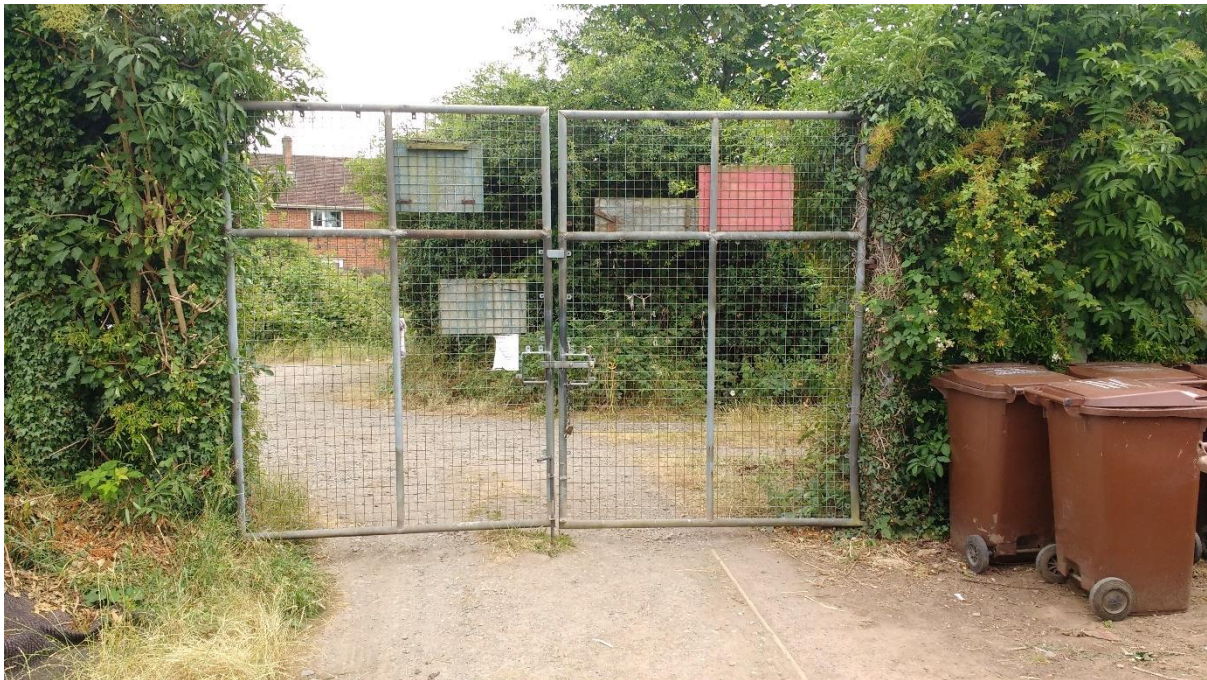
Fencing- 2.4m high Chain-link fencing around most of site. Chain-link installed in 1986 when allotments were built. Very poor condition- CBC/residents making patch repairs every time someone cuts through chain link. Approx. 220 metres of new fencing needed to replace old chain-link.

Gates- x 1 gate made of mesh metal in average condition. Would be easy to cut through mesh with pair of pliers, although this has never occurred.

Padlock- Cheap PEF 11 Lock

Break Ins- Numerous break in's over the past few years, thieves have got in by cutting through old chain link along public right of way running next to allotment.

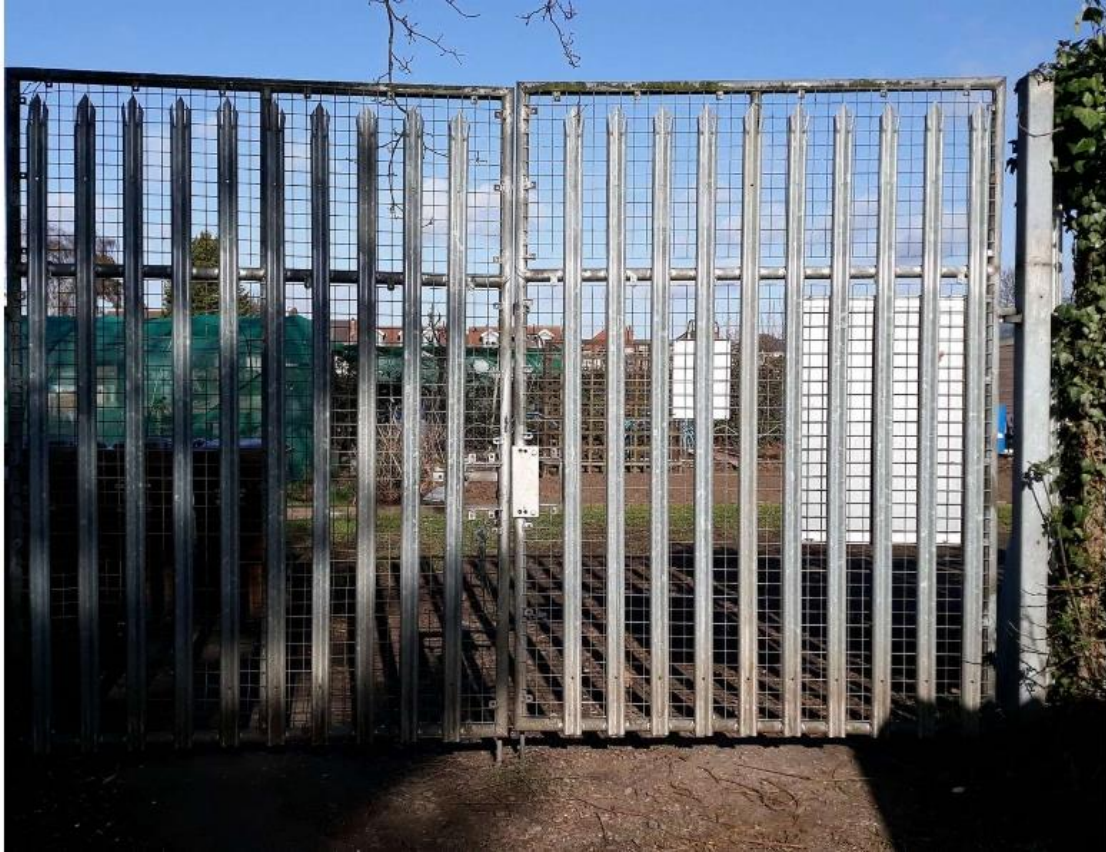
Gates- x 1 gate in good condition. Metal mesh reinforced with welded panels of palisade fencing. Paid for by plot holder approx. 6/7 years ago.

Padlock- Good quality metal, reinforced, high shouldered padlock.

Break Ins- x 2 break ins reported over the last year. Once the thieves sawed through the old cheap PEF 11 padlock to access site. Numerous sheds etc broken into and equipment stolen. Replaced padlock to a stronger one after this. New padlock is high shouldered so thieves wouldn't be able to saw through it.

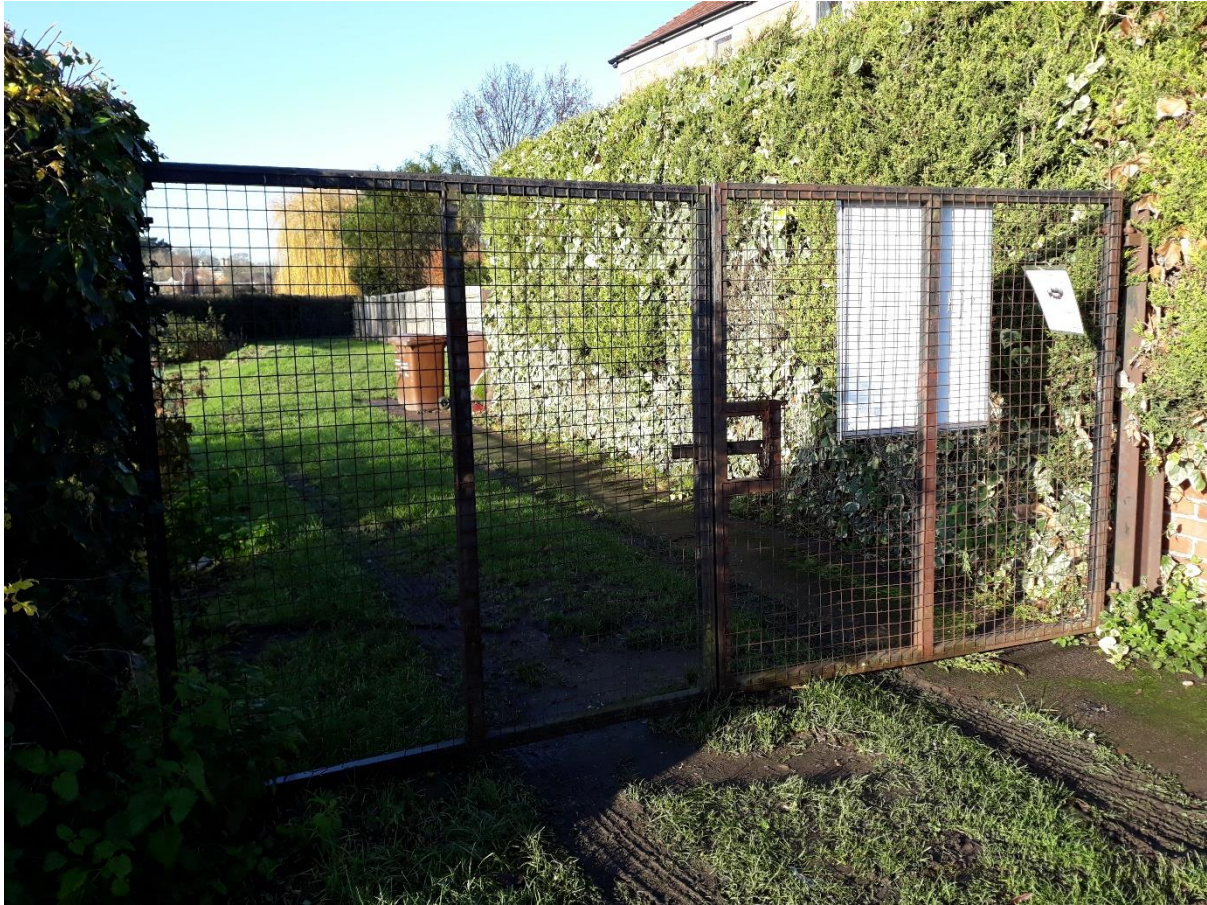
Gates- x 1 good quality metal palisade pedestrian gate and x 1 old metal mesh rusting double gate as shown below. Still in good working condition but would be

easy to cut through mesh using pliers.

Fencing- Most of site bordered by good quality Paladin fencing and residents fencing. Approx. 75 metres of old chain link fencing which needs replacing.

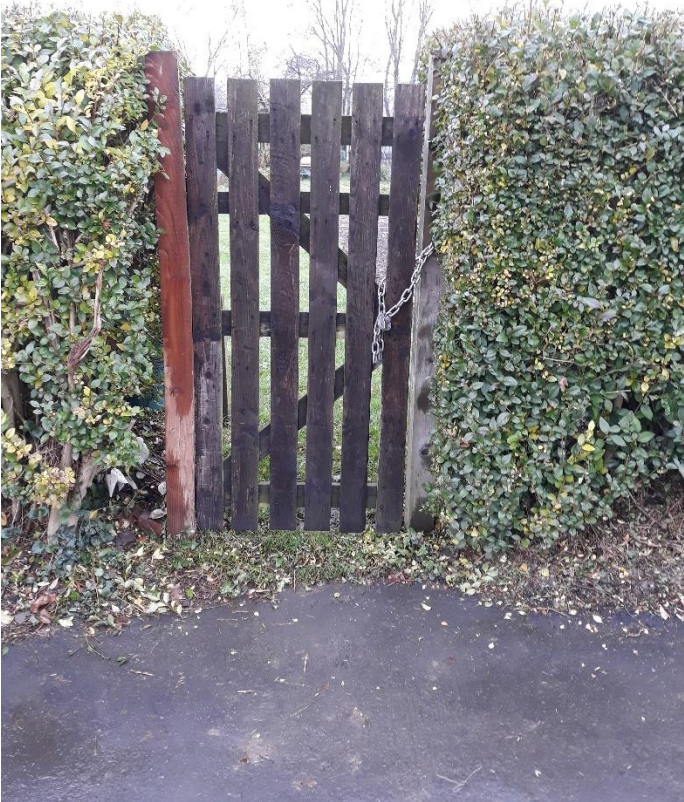
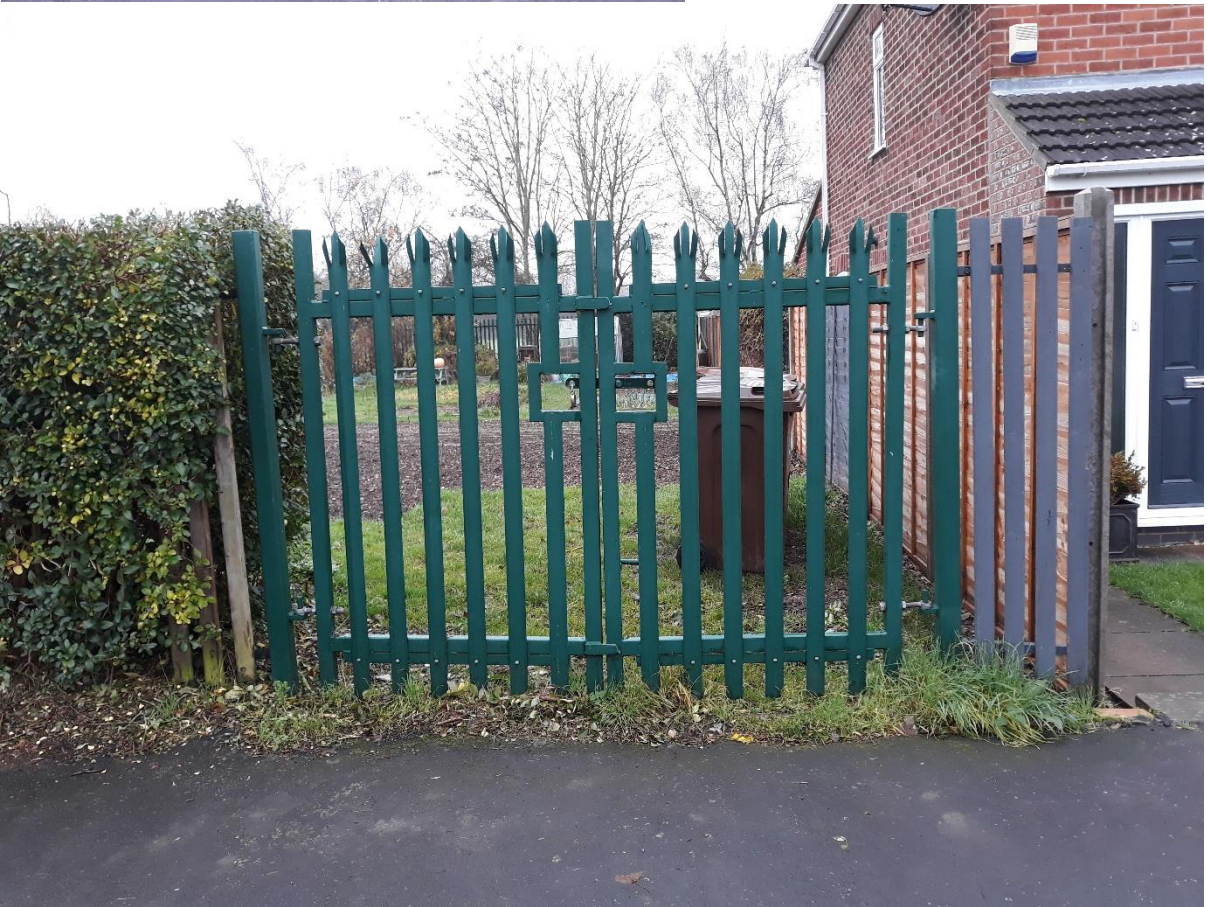
Fencing- North and South side of site is fenced- responsibility of properties next door. West side of site which backs onto cricket pitch is 6-foot-high Palisade security fencing- excellent condition. East of site has x 2 gates and old chain link fencing growing within hedge. Chain link very poor condition and $\frac{1}{4}$ of hedge very thin- would be quite easy to get through. Approx. 16 metres of fencing needed.

Gates- x 2 gates. One is a single pedestrian gate made of wood and in bad condition. One is a double vehicular access gate made of metal- good condition.

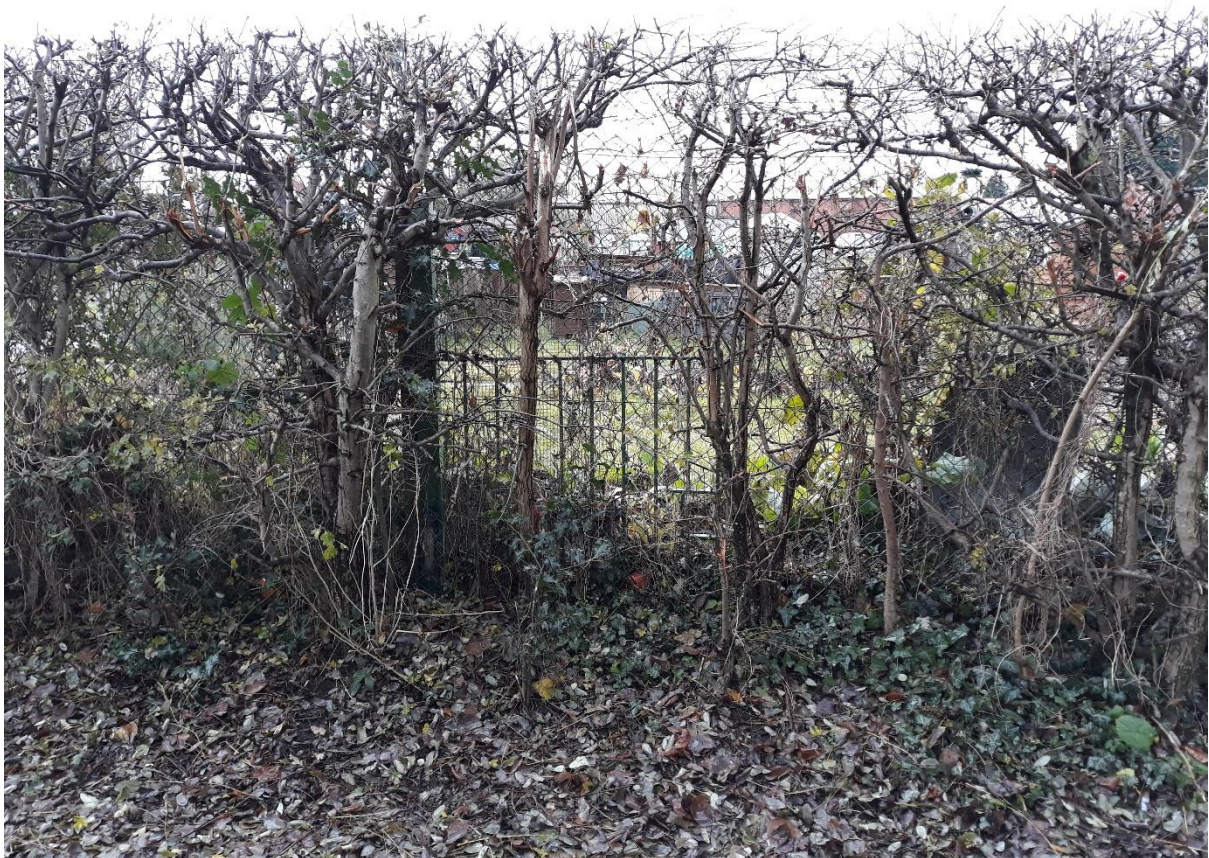
Fencing- North and South sides of site have good quality 2m Paladin fencing installed alongside hawthorn hedging. Plot holders have seen children jumping over fencing though. The East side of site is very exposed, there is very old chain-link fencing alongside very thin hawthorn hedge. Numerous incidents where thieves have stepped through the gaps in the hedge and cut through the chain link to steal from the allotments. The chain link is then patch repaired by plot holders or Idverde. Please see example of thin hedge below with patch repairs on the chain link behind. To replace all current old chain-link fencing, we would need approx. 100 metres of new fencing.

Gates- 3 gates. x 1 metal single pedestrian gate in good working condition. x 1 double gate- good working order. x 1 double gate only used by Idverde to cut the grass- good working order. Each gate has an additional 30cm of mesh metal on top covered with anti-vandal paint. Photo of main double gate below.

Break Ins- Numerous break ins reported over the last 3 years. Some reports of teenagers walking around the allotment, then jumping back over fence when confronted. Numerous reports of thieves and vandals cutting through chain-link fencing on East side of site to steal from sheds etc over last 3 years. Numerous other reports of plot holders saying their crops have been taken.

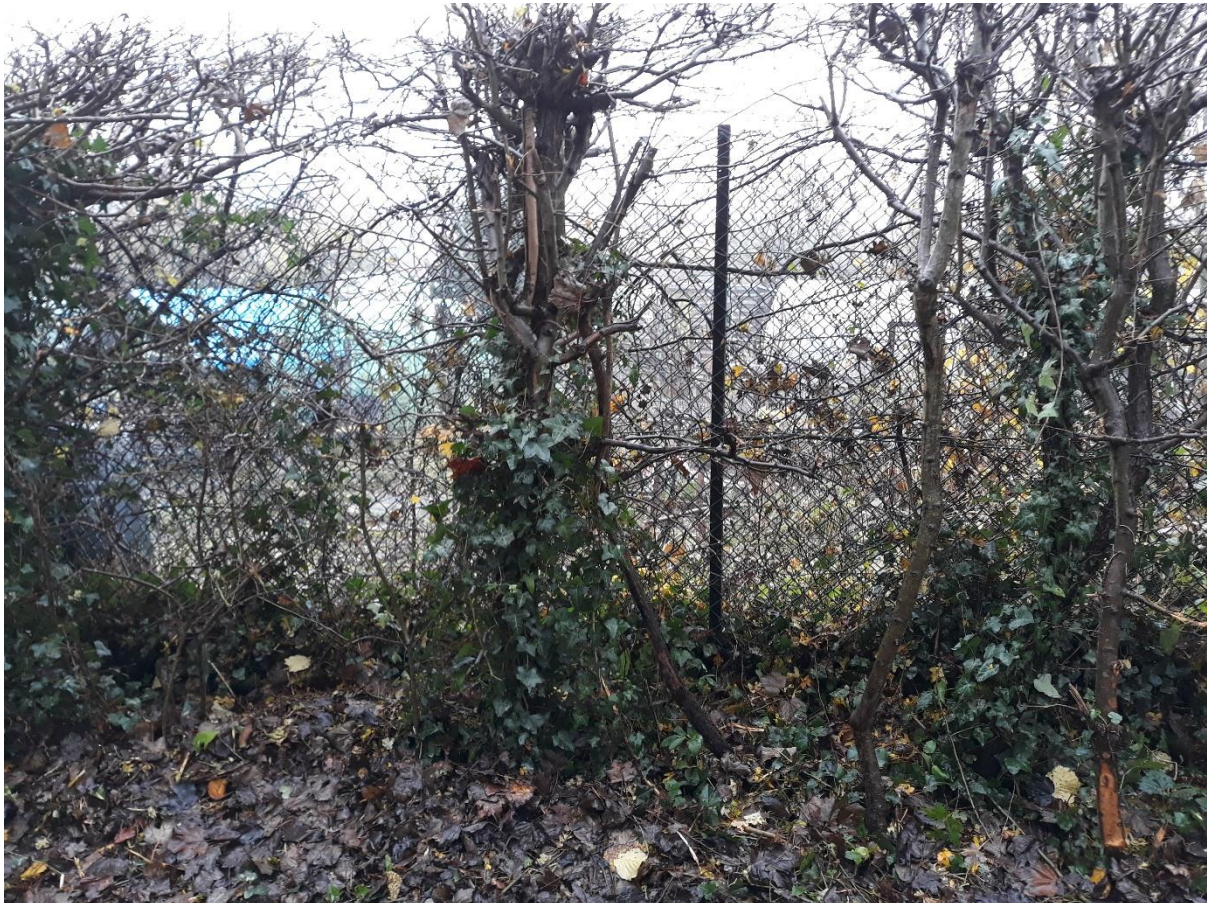
Fencing- There is a strange mix of new paladin fencing, old chain link fencing and no fencing at all on this site. The front of the site (alongside public right of way) is mostly old chain-link situated behind thin hawthorn hedge. Please see example below. We've only had 1 report of thieves getting into allotment by cutting through this chain-link fence. Would need approx. 160 metres of new fencing to replace the chain-link which is in poor condition.

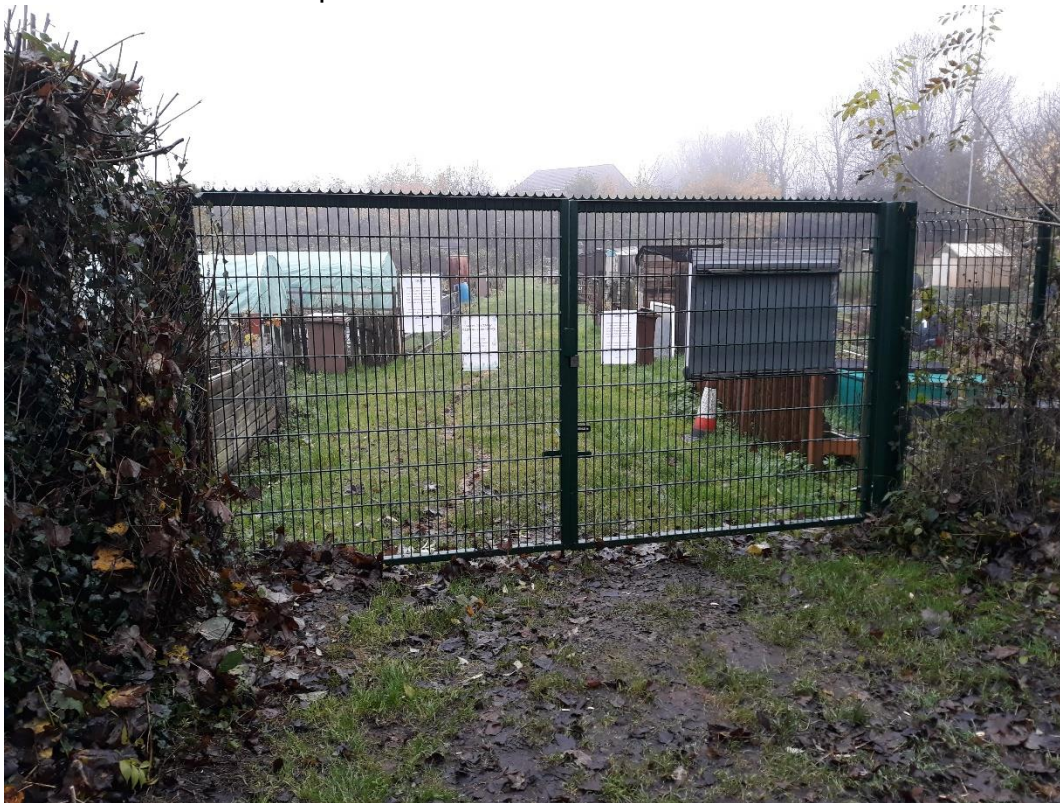
Gates- High quality metal double gates at both entrances into allotments. Gates installed in 2015. See photo of one entrance below.

Padlock- Barrel lock integrated into gates, therefore the locks can't be broken but the keys cannot be changed unless the barrels are changed.

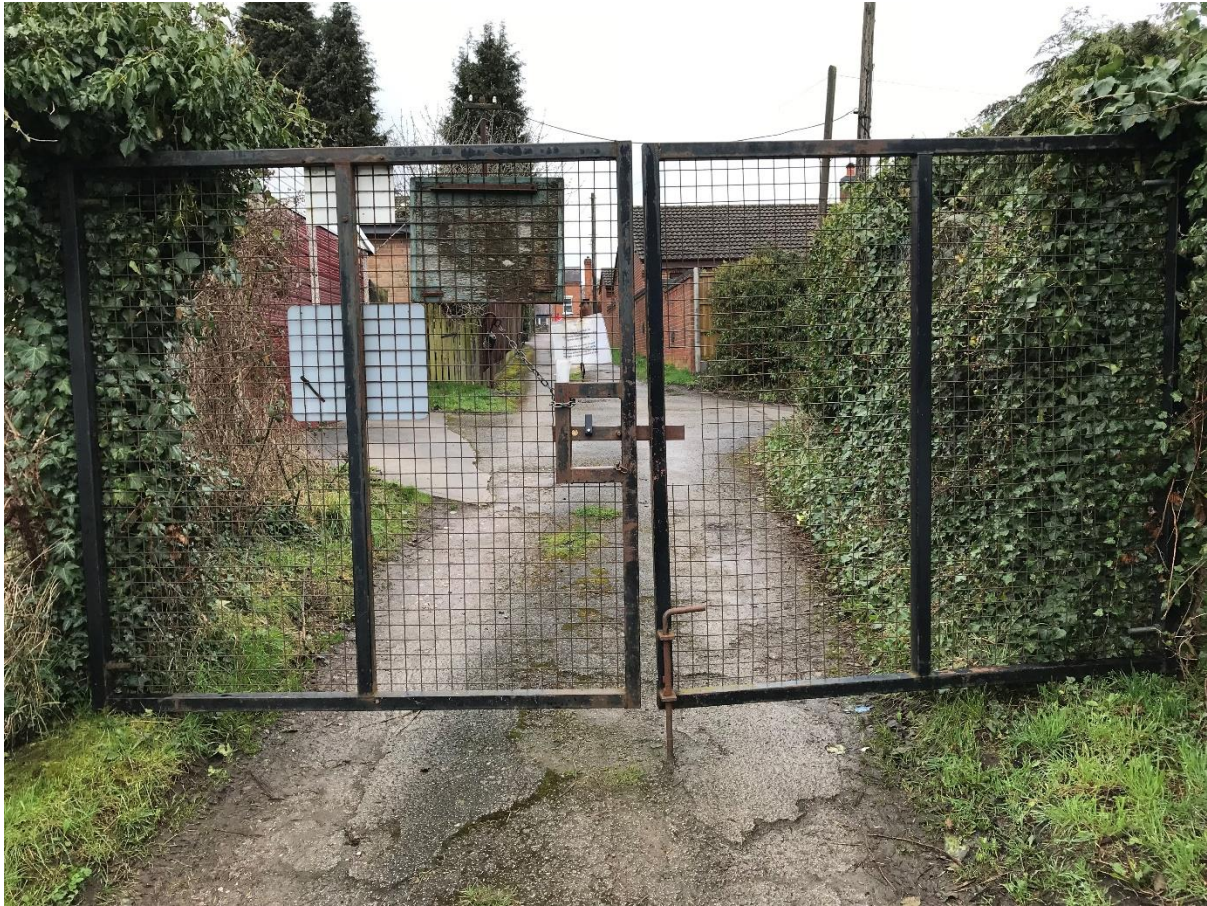
Fencing- All exposed boundaries have old chain link fencing installed which is in poor condition. All other boundaries have residents fencing installed. When break ins occur, it is usually due to the chain link being cut and thieves accessing the site this way. No hedging alongside chain link, thieves just have to get over the small stream to get to the fence. Would need approx. 200 metres of new fencing to replace the chain-link which is in poor condition.

Gates- x 1 single metal mesh gate. Good working order although showing signs of rust. x 1 double metal mesh gate. Good working order although showing signs of rust.

Break Ins- Numerous break ins reported over last 3 years. We get a lot of complaints from plot holders about other plot holders leaving the gates open, so I suspect some thefts have been because of this. 'STOP Please close the gate' signs have been installed. I've had approx. 5 incidents of thieves cutting through the chain link fencing over the last 3 years- all holes have been patch repaired.

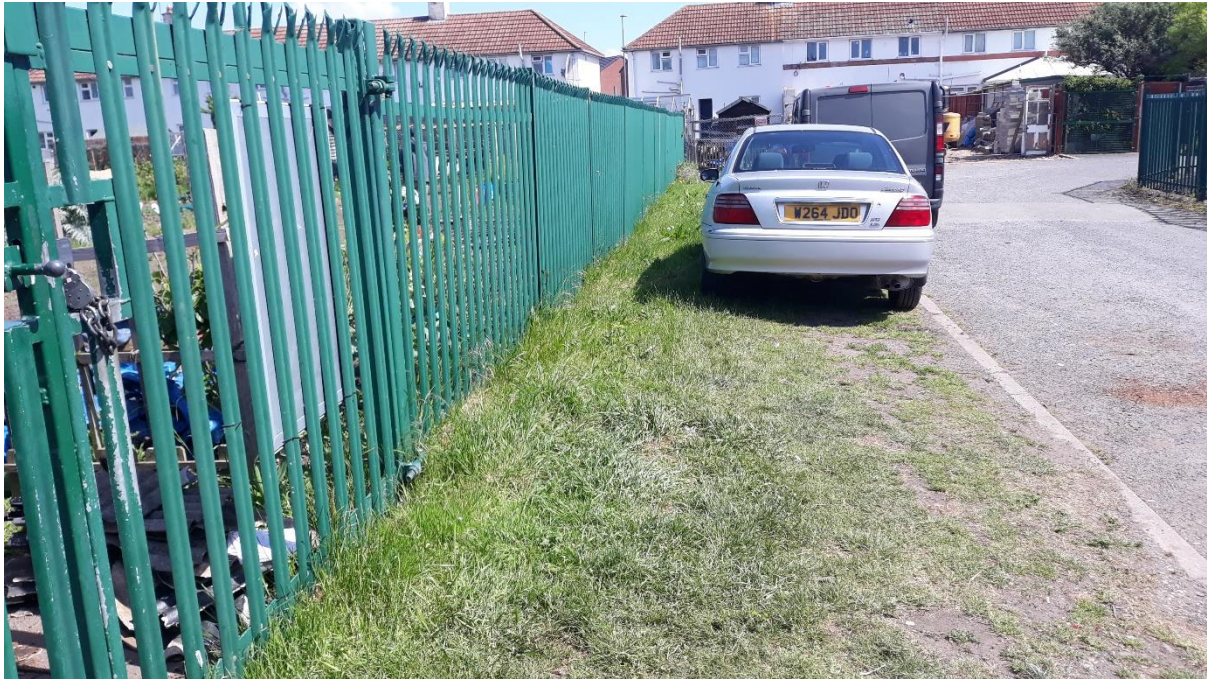
Fencing- Most of site is surrounded by resident fencing and a large brick wall to rear of site. The front of site has good quality palisade fencing at approx. 2 metres high with spiked top.

Gates- Good quality metal palisade style gate.

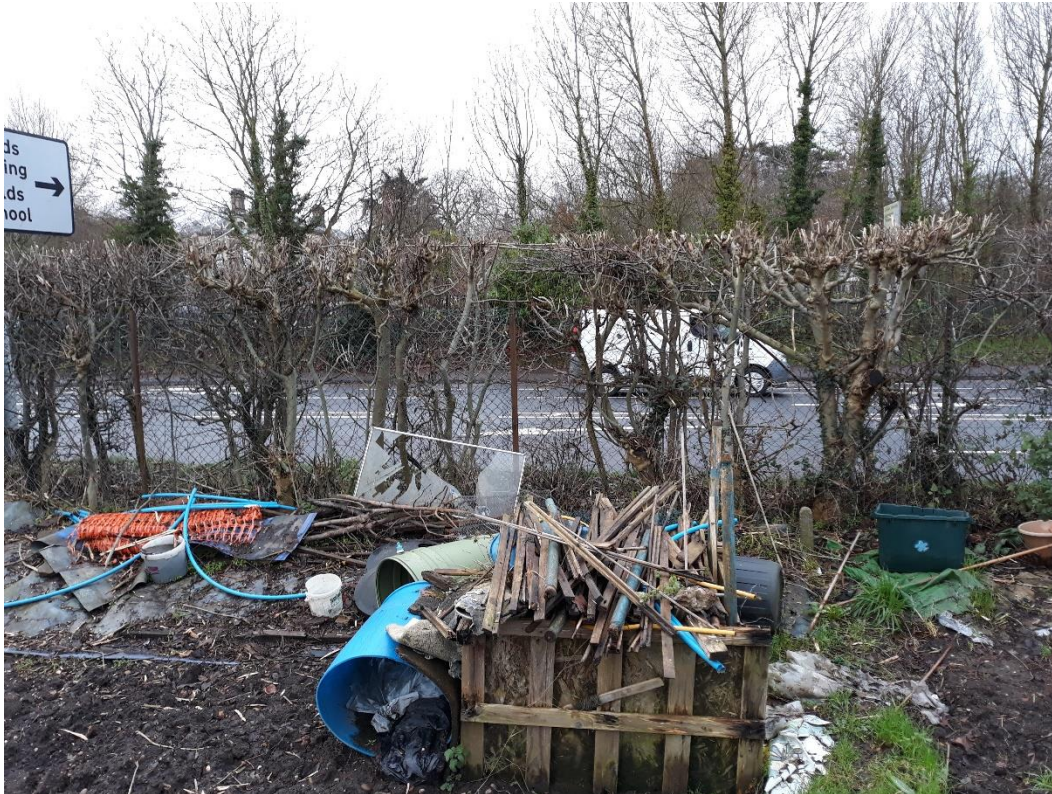
Fencing- Apart from resident fencing, most of site has old 5-foot-high chain link fencing which is in a poor condition, alongside Hawthorn hedge which is very thin in places. Please see example below. Would need approx. 300 metres of new fencing to replace the chain-link which is in poor condition.

Break Ins- Numerous break ins over the past 2 years as well as an incident a couple of weeks ago where a big hole was cut in the chain link fencing, but no one reported any thefts to me. Hole will be repaired by Idverde.

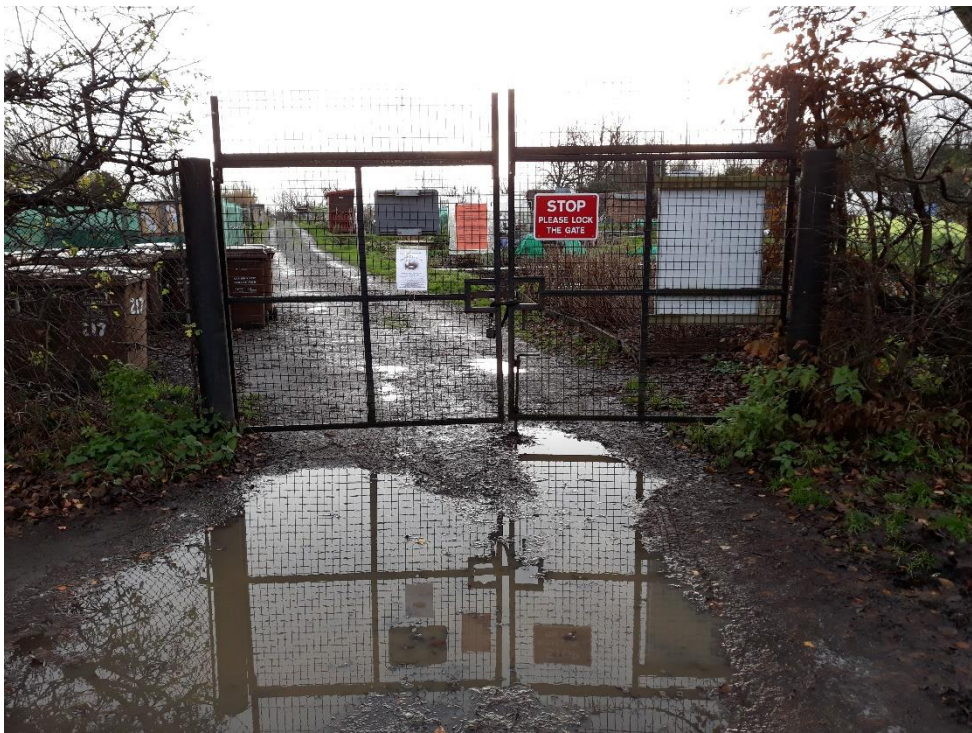
Gates- x 1 double metal mesh gate- in working order but showing signs of rust. x 1 single gate, high quality metal one installed 2 years ago. Double gate shown below.

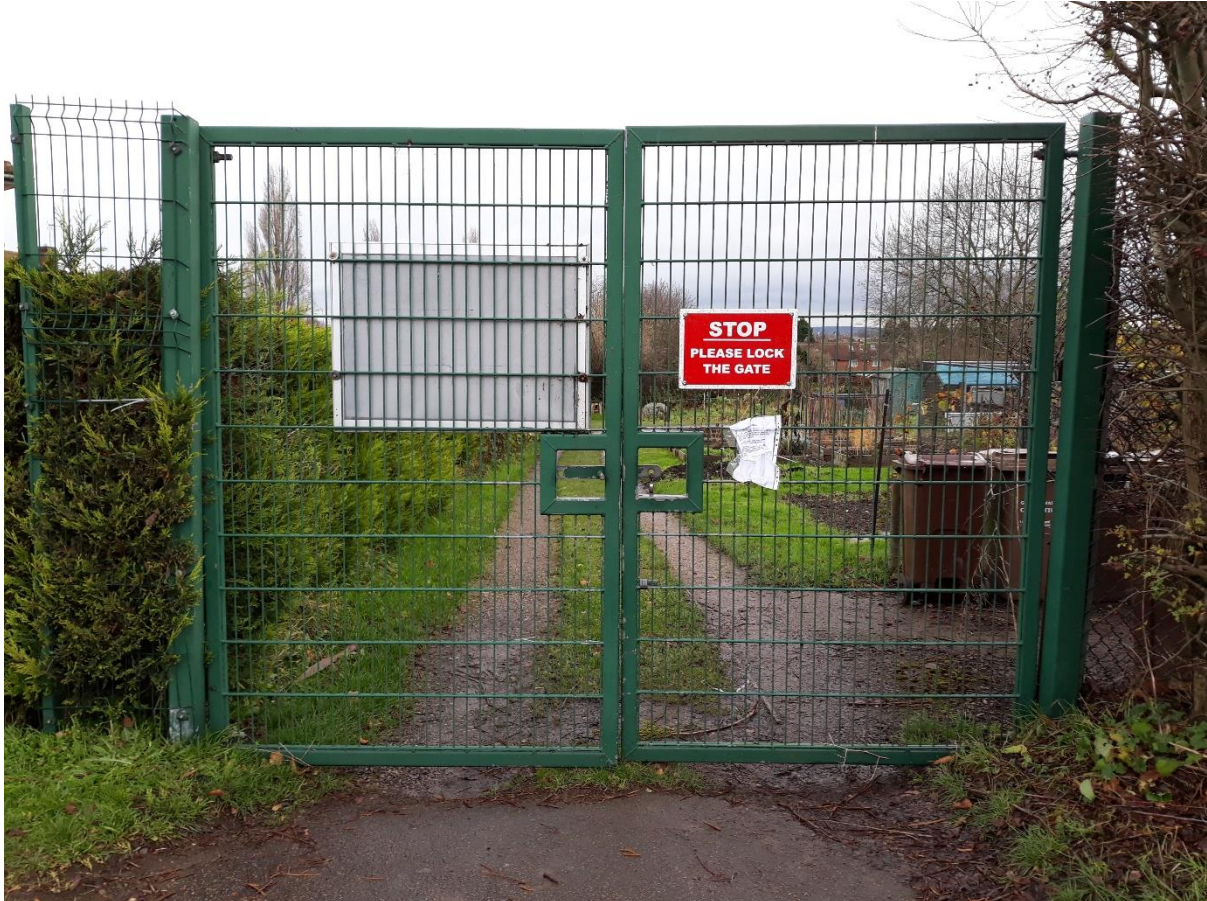
Fencing- Paladin fencing in good condition around part of allotment which backs onto the golf course. Chain-link fencing along footpath (west side of allotment) alongside hawthorn hedge which is very thin in parts. Would need approx. 130 metres of new fencing to replace the chain-link which is in poor condition.

Gates- x 1 Good quality mesh metal double gate. We have a lot of problems with it dropping and grinding against other side but this is nothing to do with security.

Break Ins- Numerous break ins over past 3 years. Most have occurred because thieves are stepping through gaps in the hawthorn hedge, then cutting through the chain-link fencing and entering site. 3 reports of this in January 2019 alone. We once had a thief cut through the paladin fencing using tools to access site. The whole fence panel needed replacing.
