129 Rothley Road, Mountsorrel
Tree Preservation Order Assessment

Client: Mrs N Baksa
12th January 2021 – Issue 1
Ref: GL1479

Report Issue 1: 12/01/2021

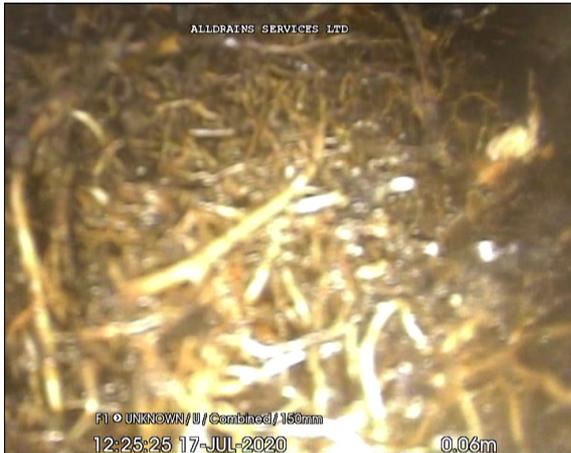
Mh F1 was found to be full of roots ,debris ,failing brick work and damaged benching
 The roots and debris were removed from MH F1 to carry out the survey (as per picture)
 MH F1 upstream has mass roots
 MH F1 A to gully has several displaced joints
 Mh F1 B to svp has several displaced joints
 Mh F1 to main has several displaced joints and root ingress

Photo: 1_4A, 00:00:11
0.6m, Roots, mass, 95% cross-sectional area loss

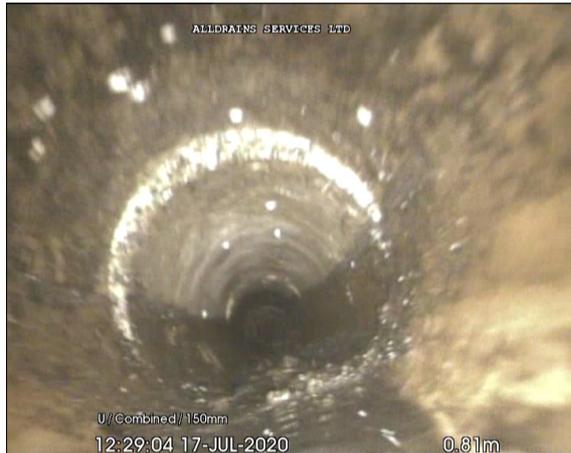
Photo: 2_4A, 00:00:09
 0.91m, Joint displaced, medium (between 1.0 and 1.5 times the pipe wall thickness)

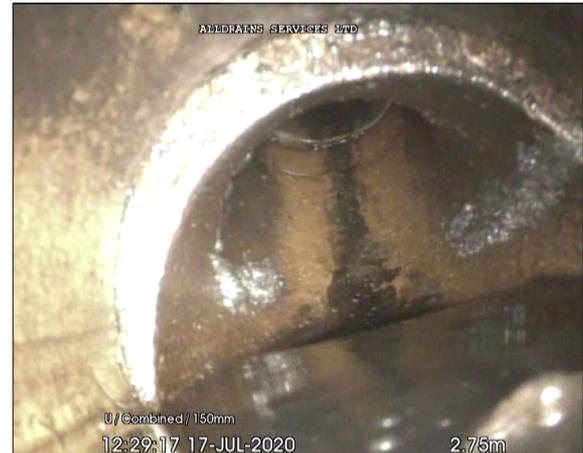
Photo: 2_5A, 00:00:22
 2.75m, Joint displaced, medium (between 1.0 and 1.5 times the pipe wall thickness)

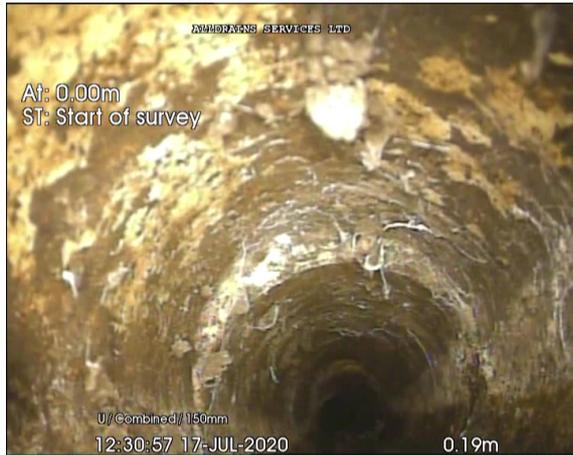
Photo: 3_4A, 00:00:07
0.18m, Joint displaced, medium (between 1.0 and 1.5 times the pipe wall thickness)

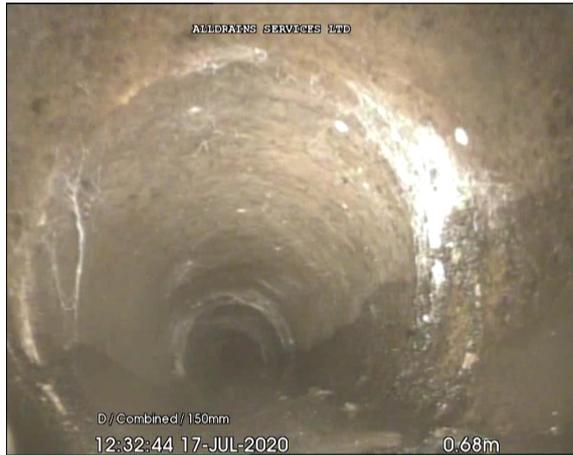
Photo: 4_4A, 00:00:10
0.68m, Joint displaced, medium (between 1.0 and 1.5 times the pipe wall thickness)

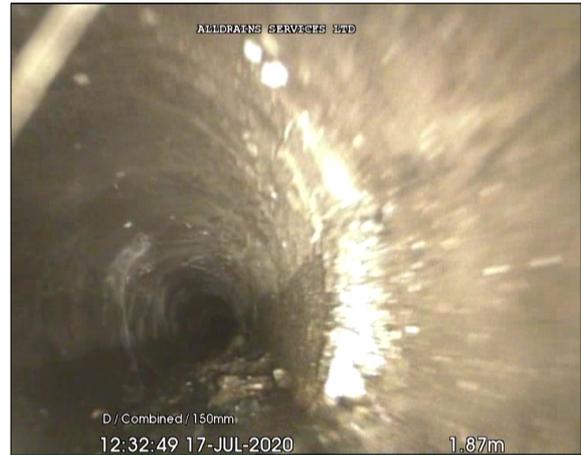
Photo: 4_5A, 00:00:14
1.87m, Joint displaced, medium (between 1.0 and 1.5 times the pipe wall thickness)

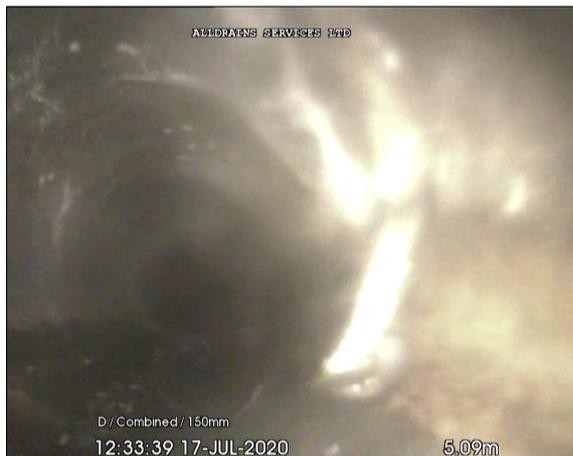
Photo: 4_6A, 00:00:39
5.09m, Joint displaced, medium (between 1.0 and 1.5 times the pipe wall thickness)

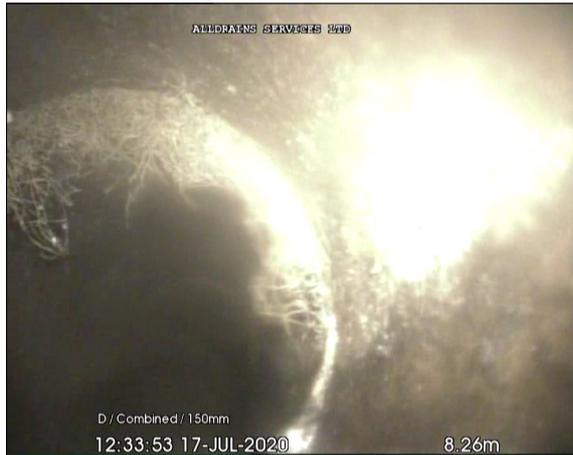
Photo: 4_9A, 00:00:52
8.26m, Roots, fine at joint

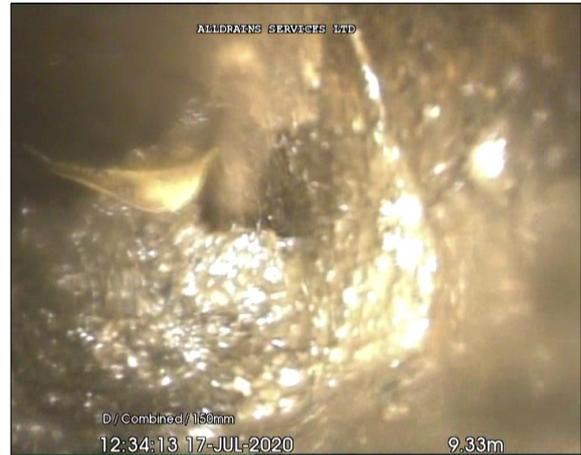
Photo: 4_10A, 00:01:13
9.33m, Debris, 25% cross-sectional area loss

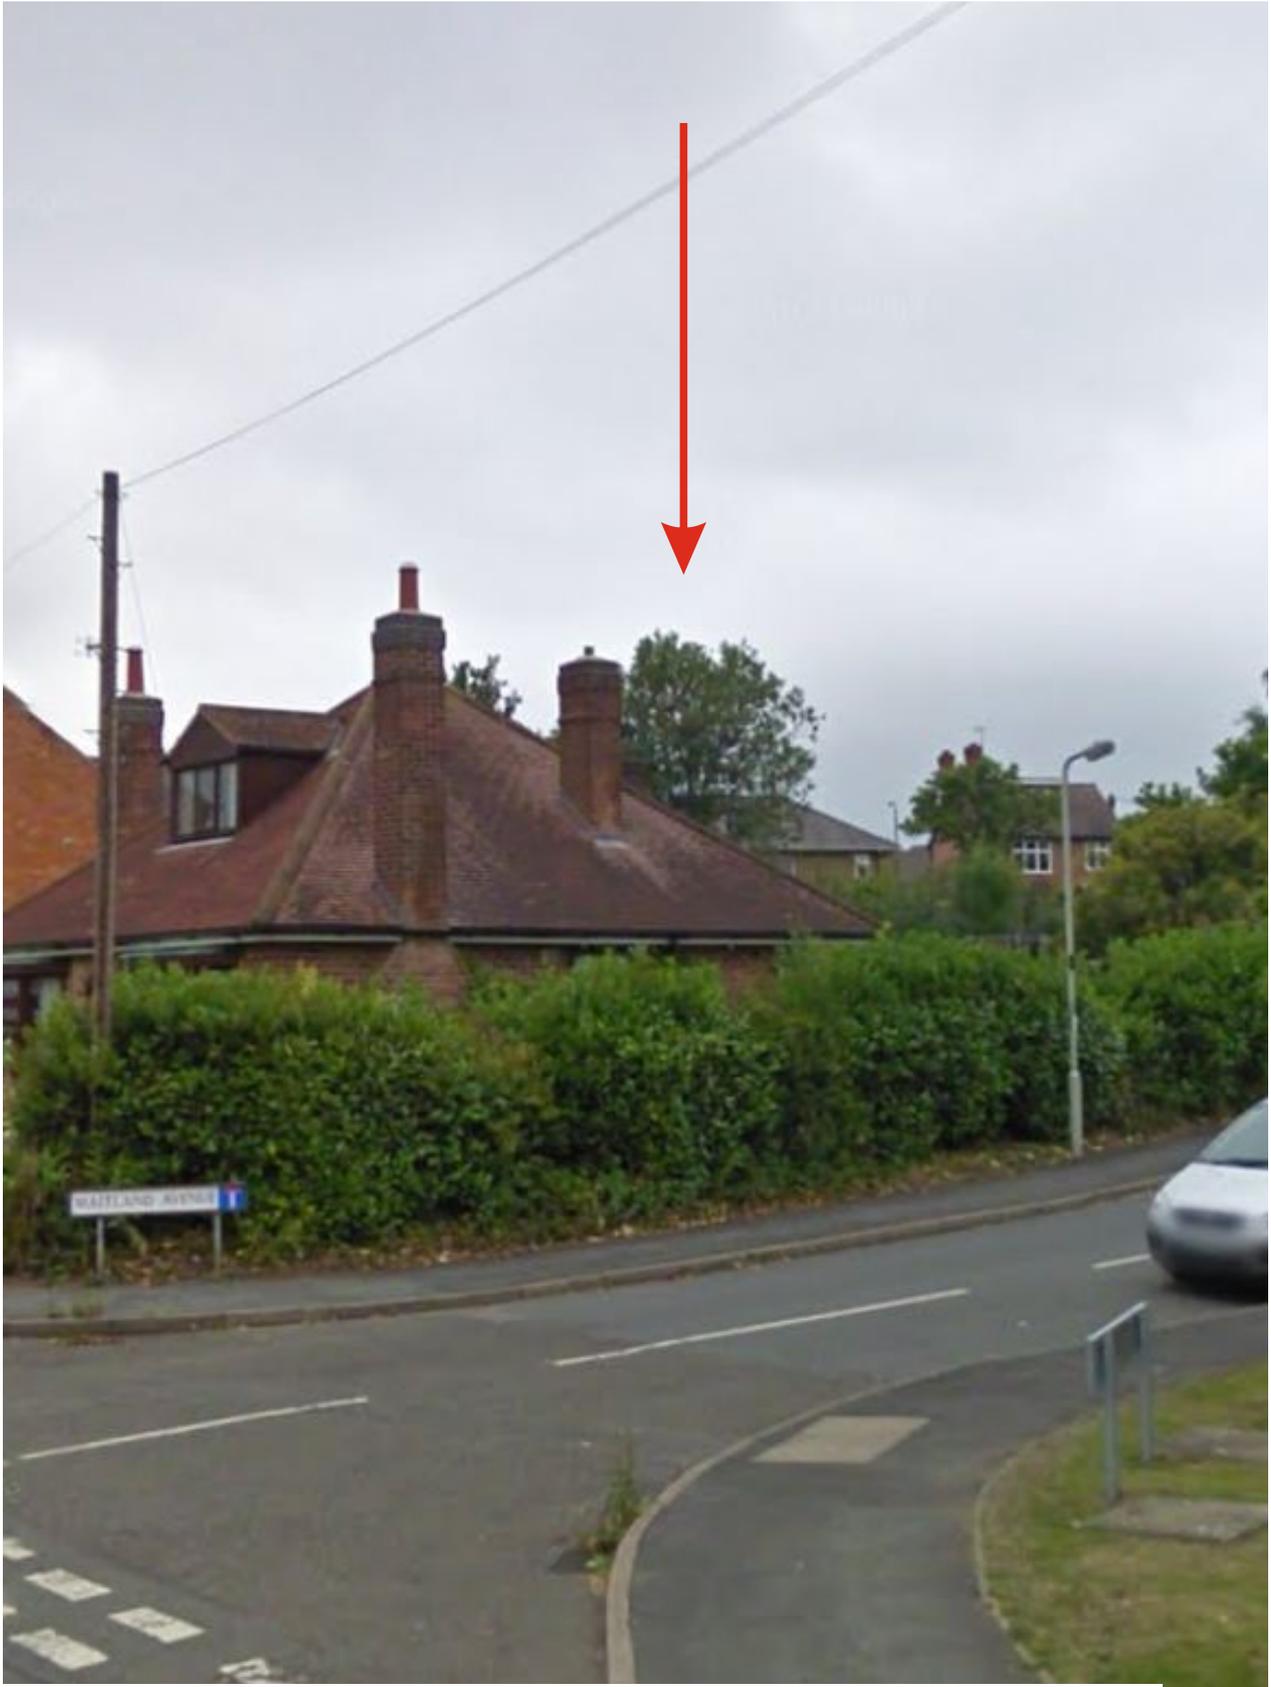
3.2 Tree T1 is an early mature ash situated in the north-eastern corner of the garden. The tree appears in **good** physiological condition and has a broadly symmetrical canopy supported by two primary stems which emanate from a bifurcation on the main stem at 1m above ground level. The junction of the stems exhibits a minor bark inclusion. There is sufficient proportions of supporting wood below the union such that likelihood of failure is very low. The tree is considered to be in **fair** physiological condition. The tree's current condition suggests an estimated safe remaining contribution of 20+ years.

5.2 The tree is in normal condition and in its current condition has a life expectancy of 20+ years. It is a fair example of the species and can be seen clearly from adjacent public vantage points on Linkfield Road and Maitland Avenue, see **photograph 1, Appendix C**. As such, its removal would be considered likely to have some negative impact to public amenity. As a native species, the tree also has some biodiversity value as an individual tree. Consequently, it is concluded that the tree is considered **suitable** for inclusion in the Order.

Photograph 1 - T1 as viewed from the junction of Maitland Avenue and Linkfield Road.

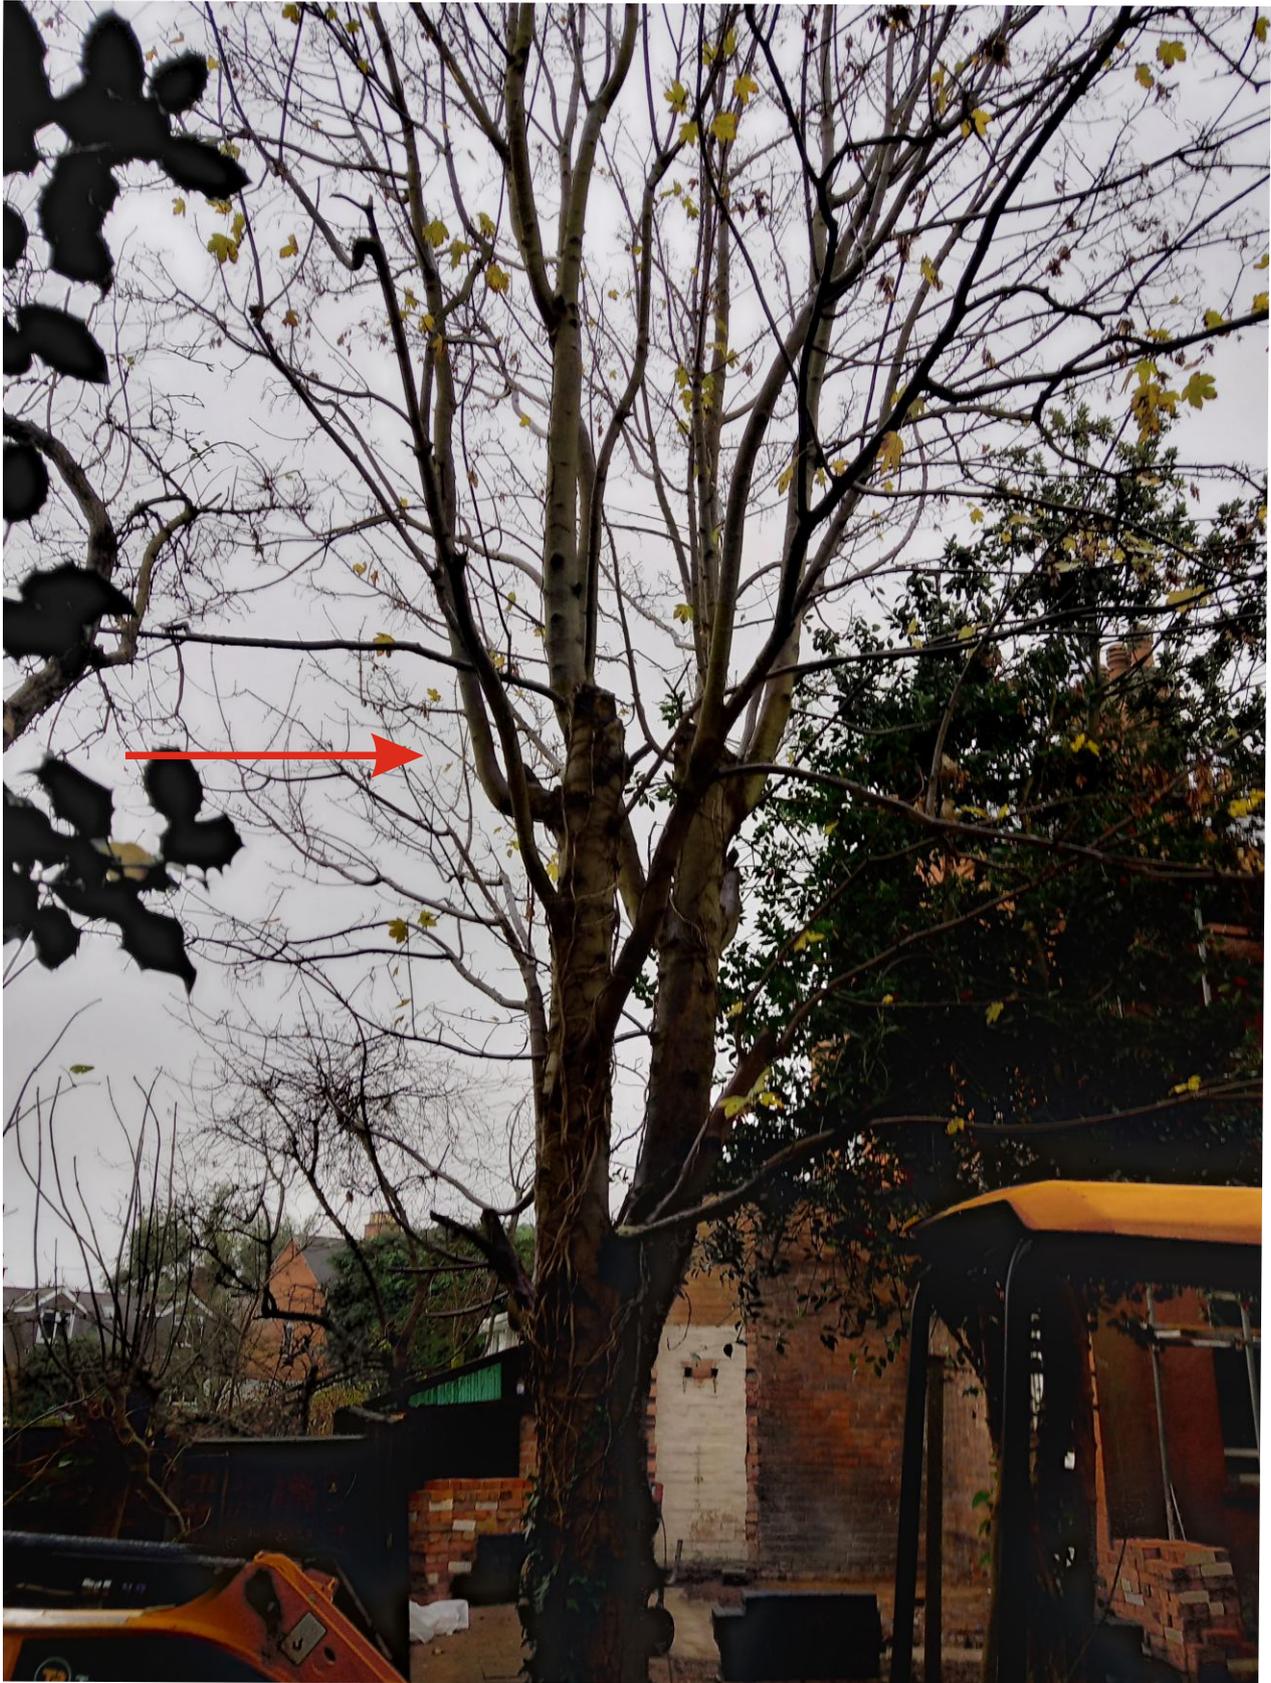
3.4 Tree T2 is a semi-mature sycamore which has established in the property garden as a result of the species typical self-colonisation. The tree appears in **good** physiological condition but presents a series of structural defects that suggest **poor** structural condition. These include squirrel damage and evidence of particularly poor historic pruning.

5.3 The tree is a poor condition sycamore with several defects that will significantly hinder its development as a specimen of arboricultural merit and visual potential, see paragraph **3.4** and **photograph 2, Appendix C**. The tree is also causing significant issues with the property drains which will worsen if left to mature, see **Appendix B**. For these reasons, T2 is considered **unsuitable** for retention in the Order and should be excluded.

Photograph 2 - Evidence of poor historic pruning and poor form in T2.

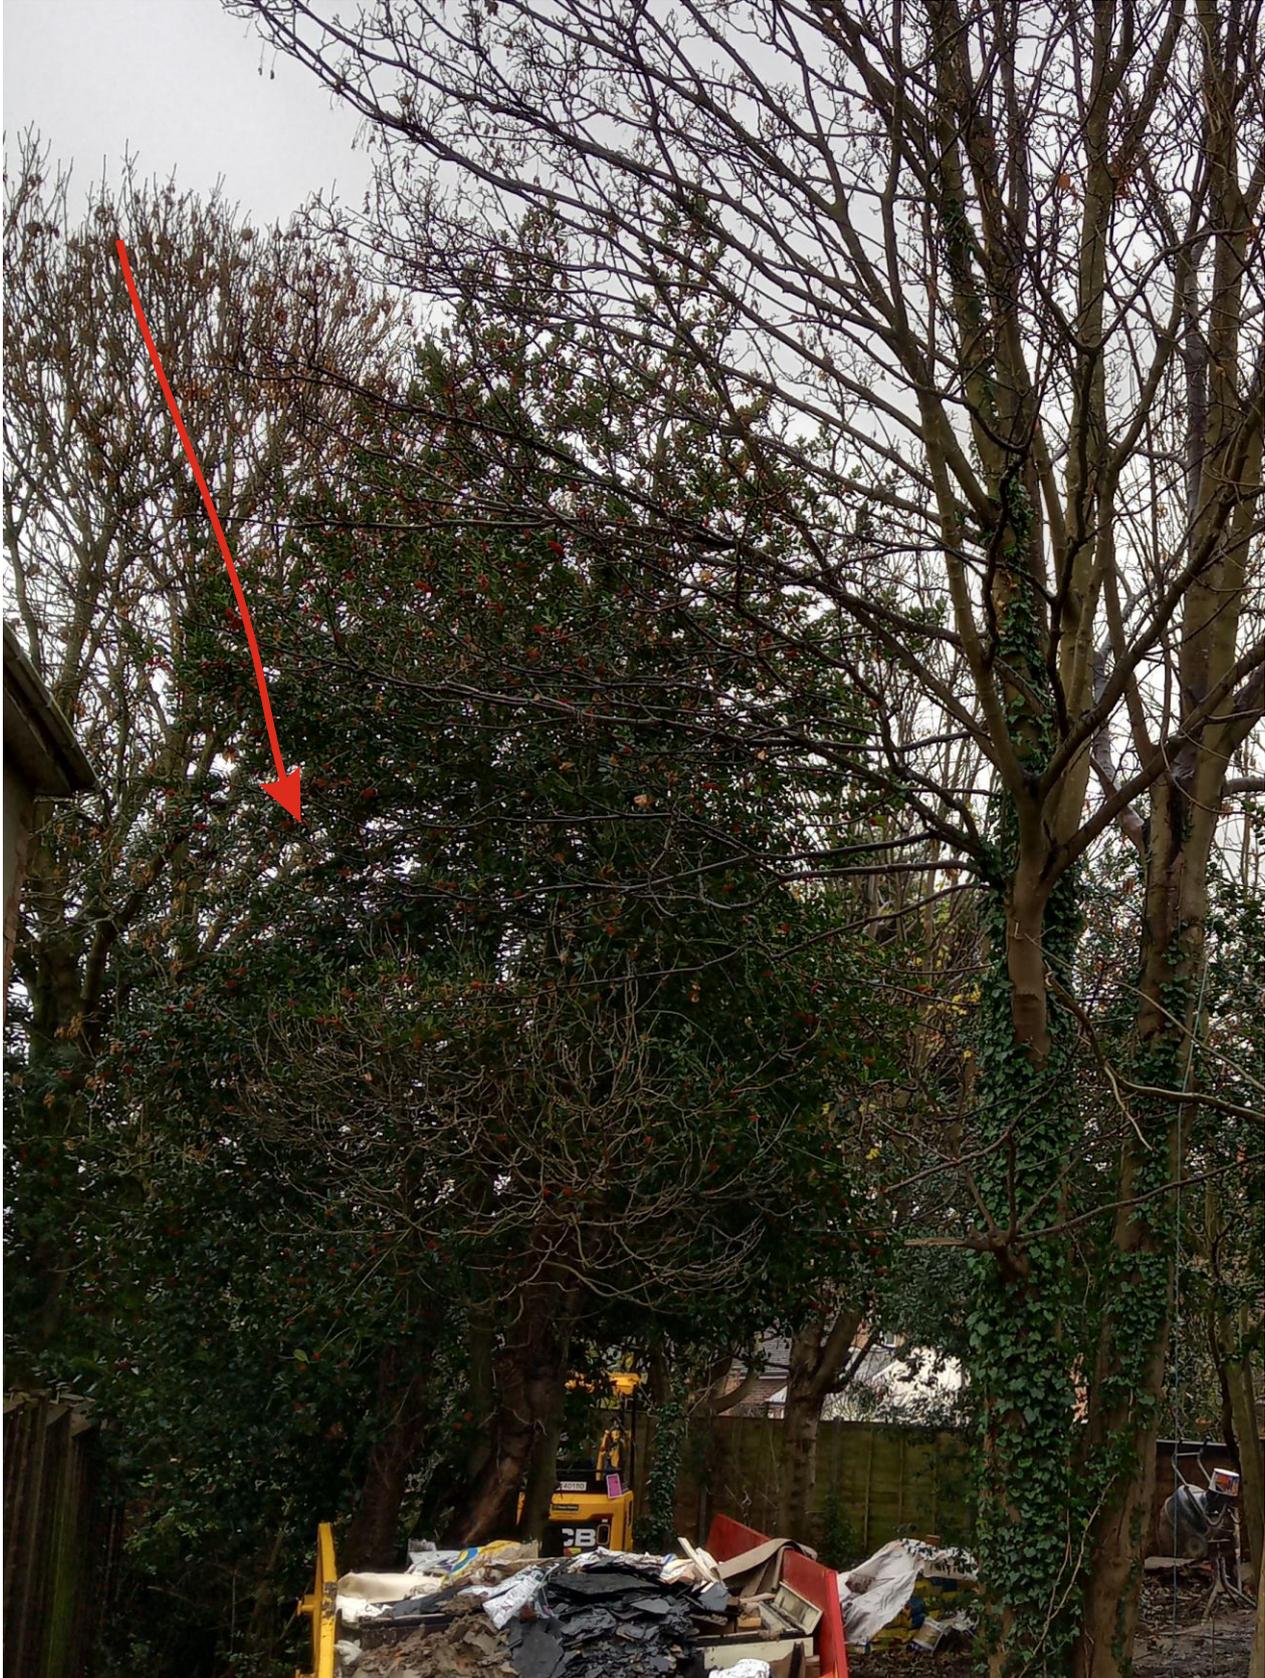
suppressed branch development to the north, indicating **poor** structural condition that is unlikely to improve given time, see **photograph 3, Appendix C**. It has an estimated safe remaining contribution of 20+ years.

Photograph 3 - Displaying the multi-stemmed form of T3 and the suppression and poor branch development in the north canopy.

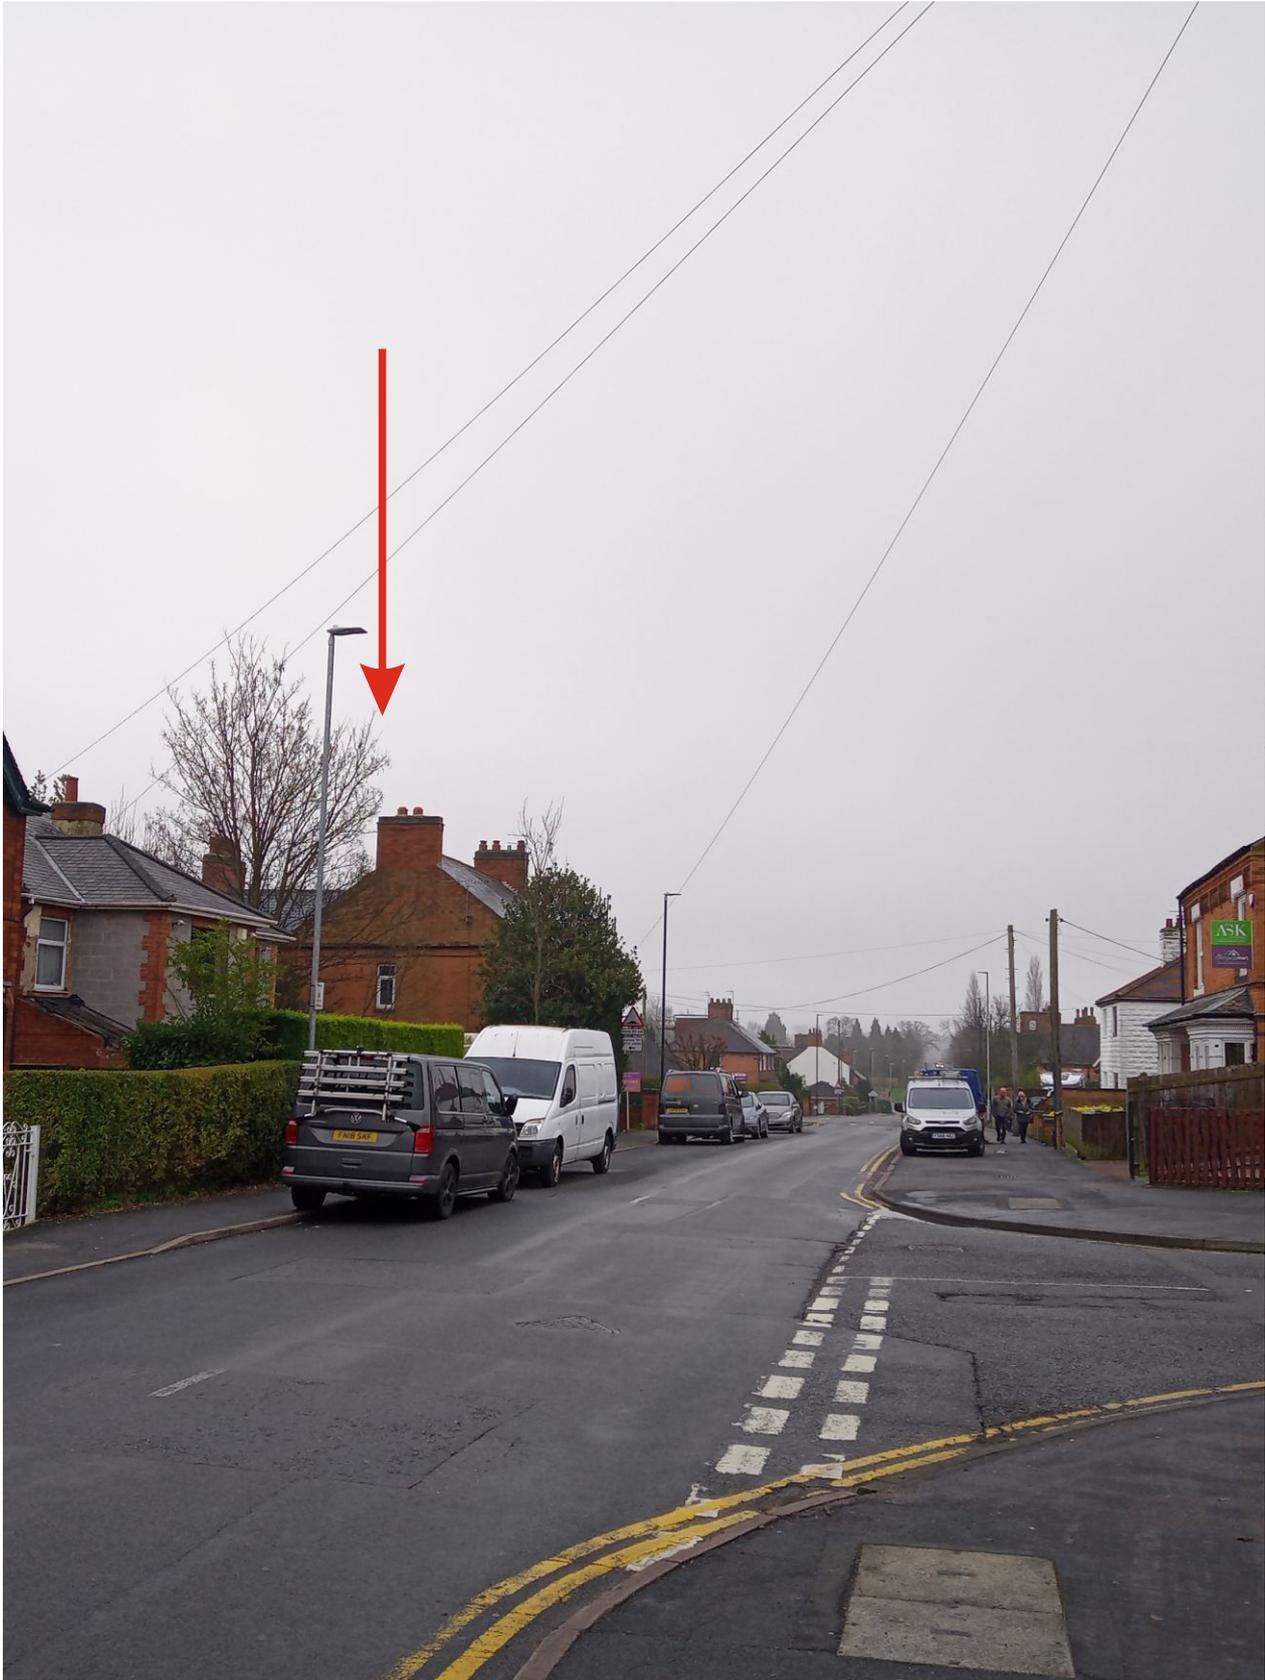
- 5.8 In terms of amenity value, while visible in the public domain it does not form a notable feature, nor does it present as a good example of the species or display a particularly aesthetically pleasing appearance, see **photographs 4 and 5, Appendix C**. Its position on the property causes identical issues to the sycamore T2, as detailed in paragraph **5.4**. The tree is a non-native alien species. It is not rare, it has no identifiable cultural or historic value and it has no important identified relationship with the surrounding landscape or heritage designations. The defects recorded limited its safe life expectancy and potential to increase in amenity value. The tree's inclusion in the Order would place an unreasonable burden on the landowner, that is not outweighed by any identified public benefit. It is therefore concluded that T4 is **unsuitable** for retention in the Order and should be excluded.

Photograph 5 - Displaying Rothley Road looking south. Views of trees T2 and T3 are not obtainable due to their position behind housing. T4 is visible in part and T5 is visible adjacent to the footpath at the property front.

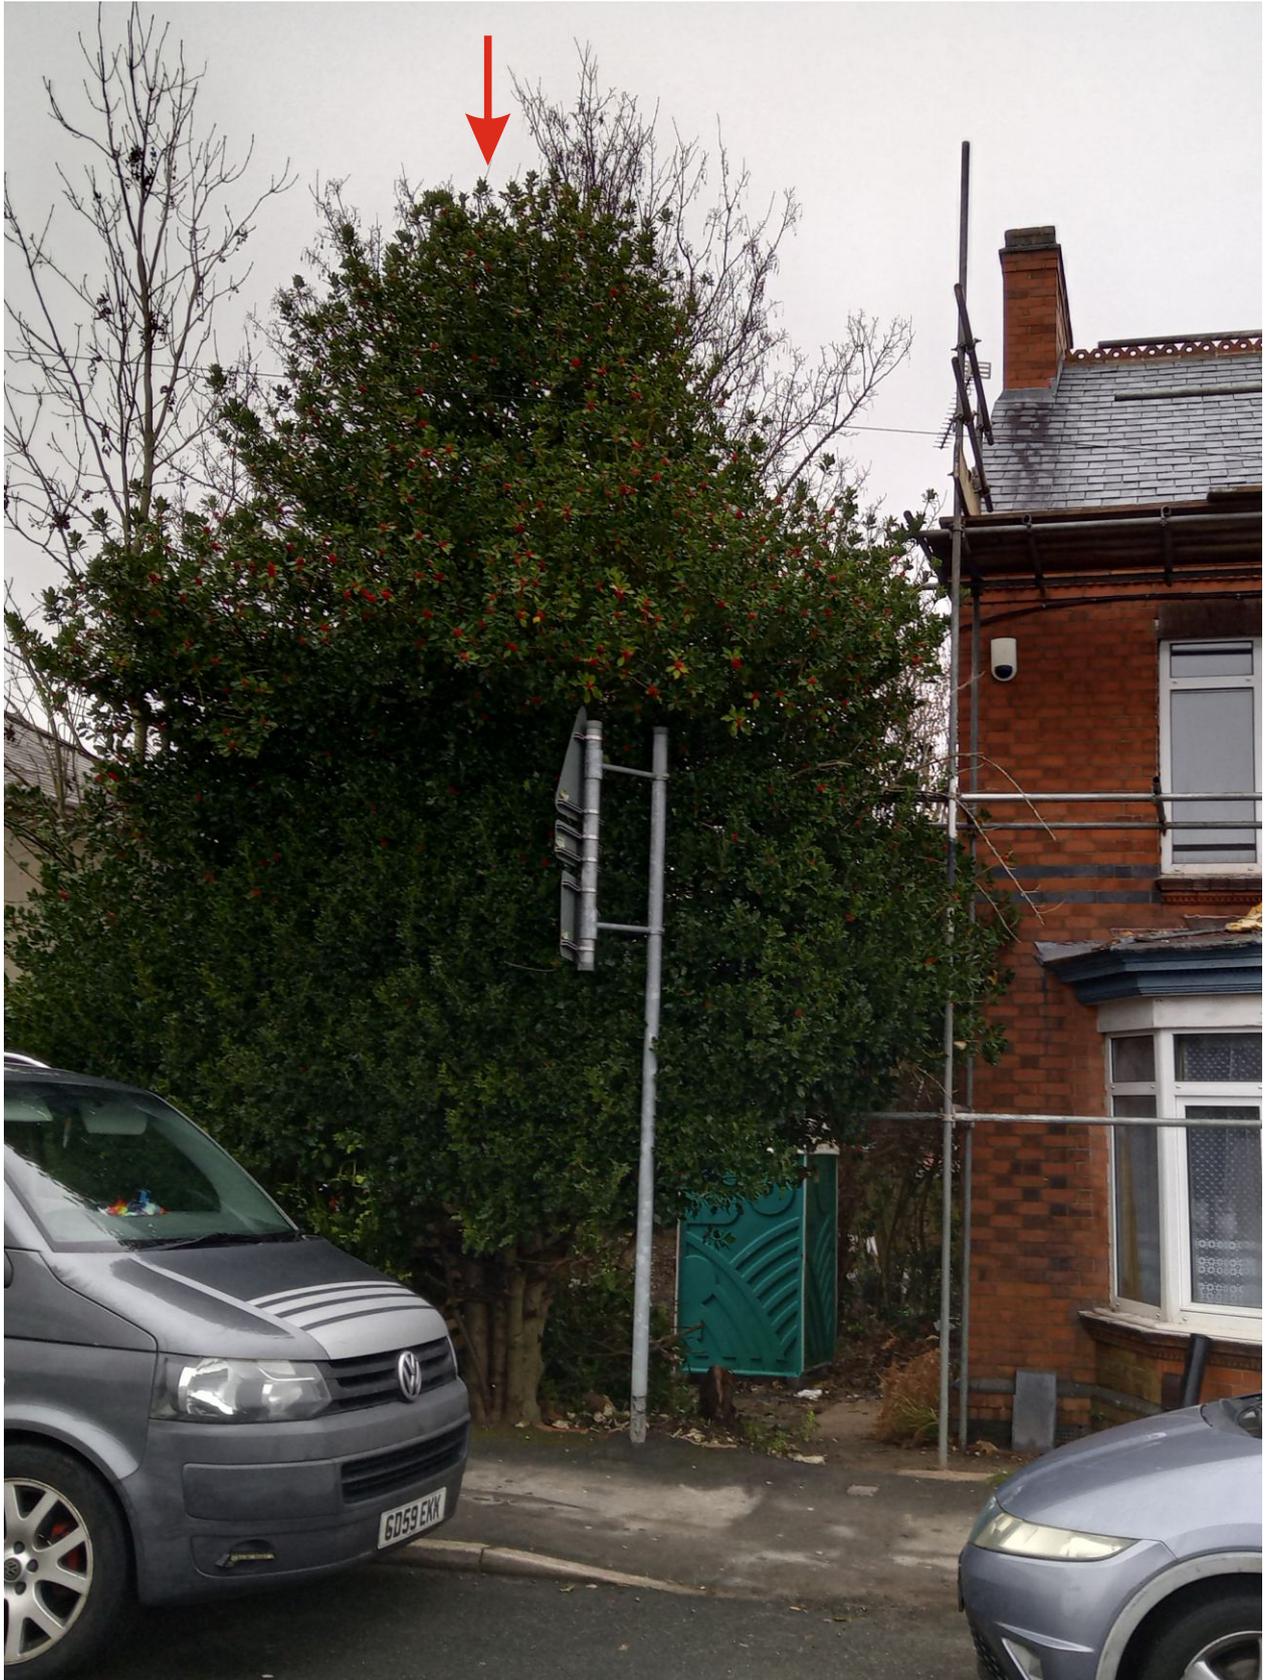
- 3.15 T5 is a section of hedge that has not been trimmed for several years, such that upward growth has developed from the main hedge structure. The hedge structure is established to an approximate height of 3-4m and trimmed back from the footpath, with further apical growth above. It appears in **good** physiological condition. Its structural condition is of limited relevance given its intended management as a hedge; it is outgrown but this is not suggestive of poor structural condition or any risk of failure. It is visible in the streetscene and adds a minor green element to the street, but not one of any particular stature or visual quality. Indeed, its lack of management is evident in its untidy appearance, see **photograph 6, Appendix C**. It is considered to be of minimal amenity value. It is a single native tree to which some wildlife value can be attributed, though this does not extend beyond nesting habitat and food resource, which most hedges provide to some degree. The hedge is not rare or unusual and is not related to a heritage designation.

Photograph 6 - Displaying T5 as viewed from directly opposite the no. 129 from Rothley Road.
