DRAFT REPORT OF THE HEAD OF PLANNING AND REGENERATION

APPEALS AND REVIEW COMMITTEE – 1 April 2019

Provisional Tree Preservation Order – 1 & 3 Soar Road Quorn

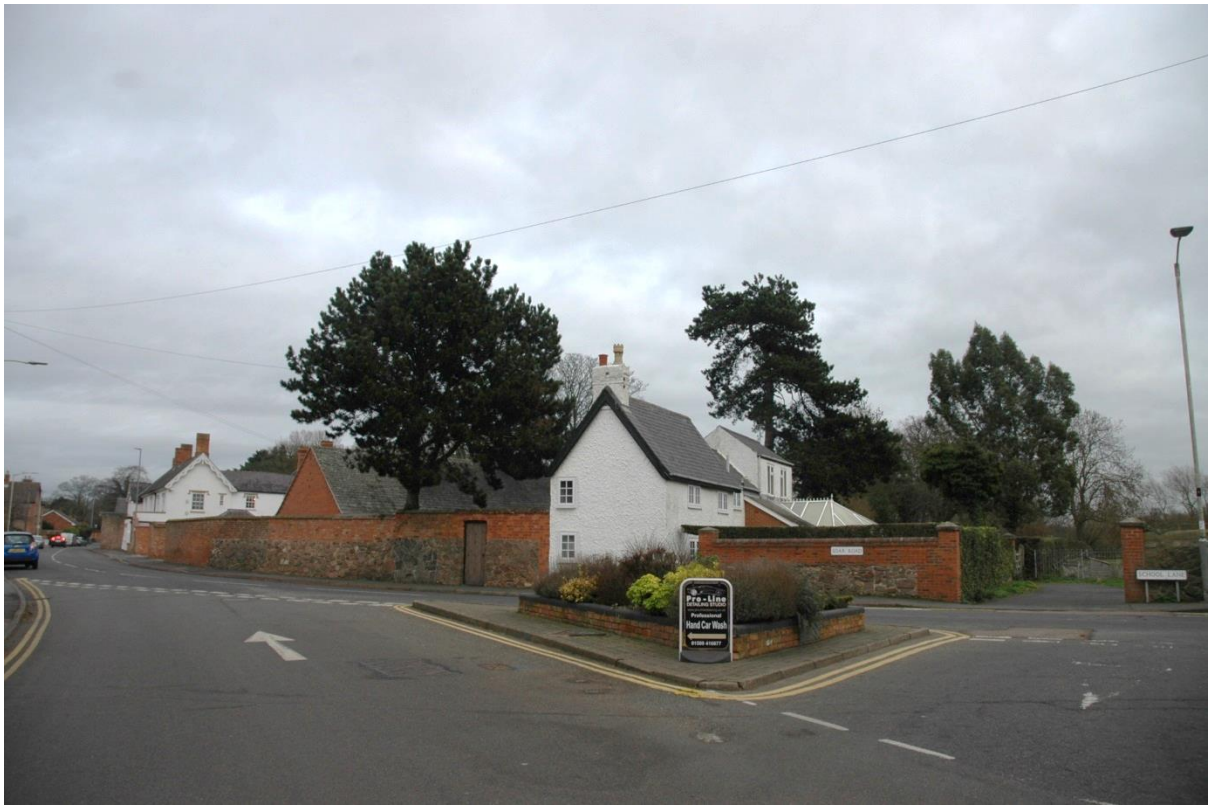
This image illustrates the contribution of the tree pines to the Conservation Area and their relation to each other.

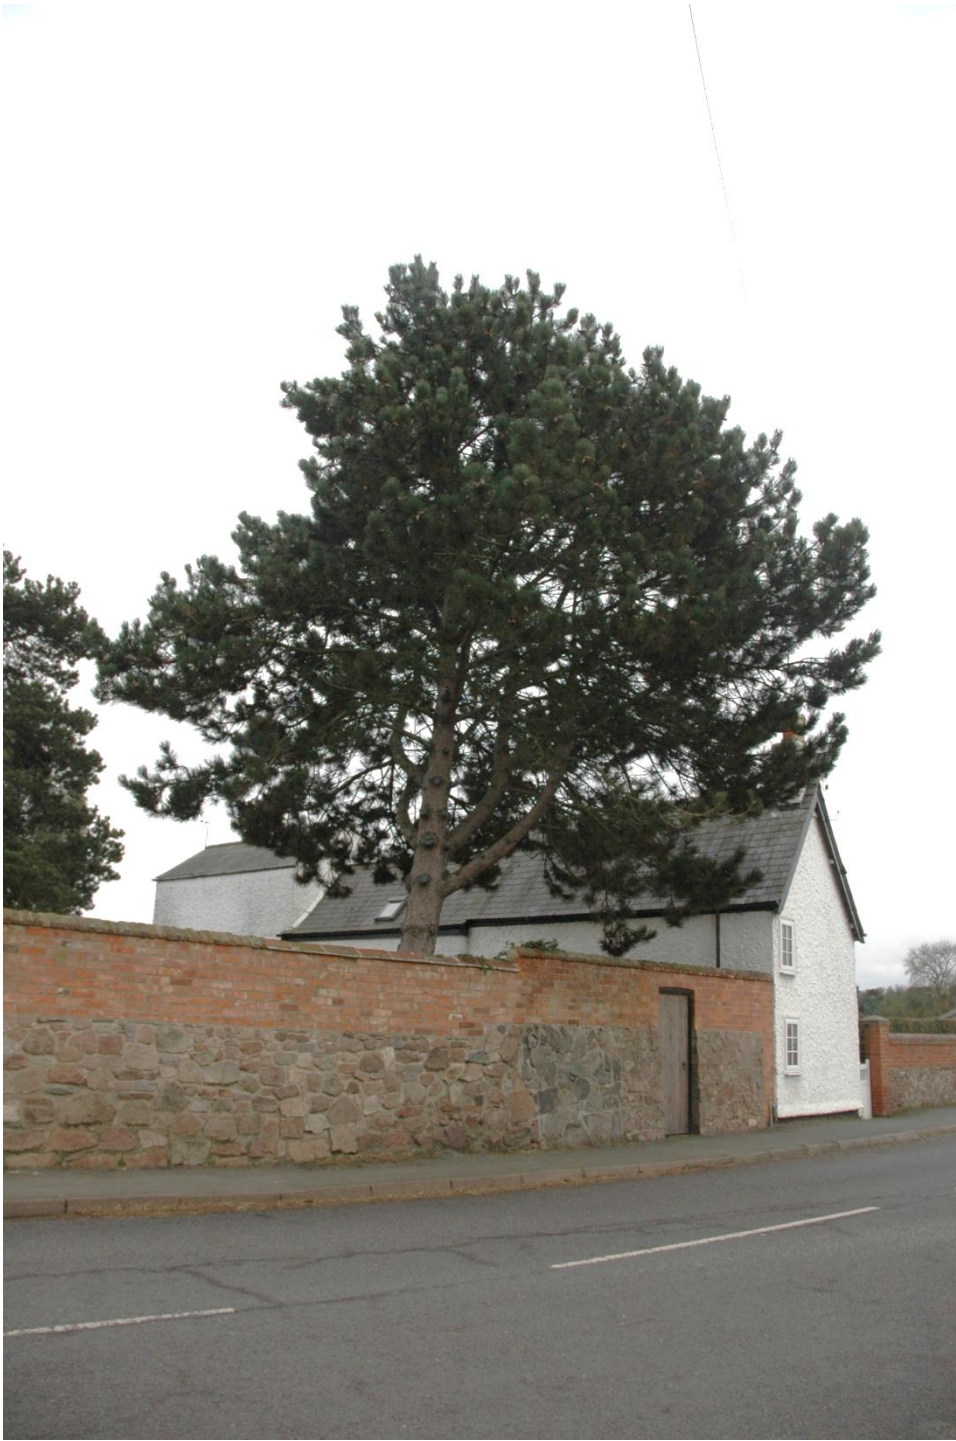
It remains my opinion that the tree is not the main cause of collapse though it may have contributed to weaknesses in the structure. It is possible to prevent a tree penetrating a wall or its foundations by taking the larger anchor roots into account in the construction methodology and deflecting other feeder roots using a proprietary product for root deflection.

This is the pine at no 3 Soar Road and the reconstructed wall.

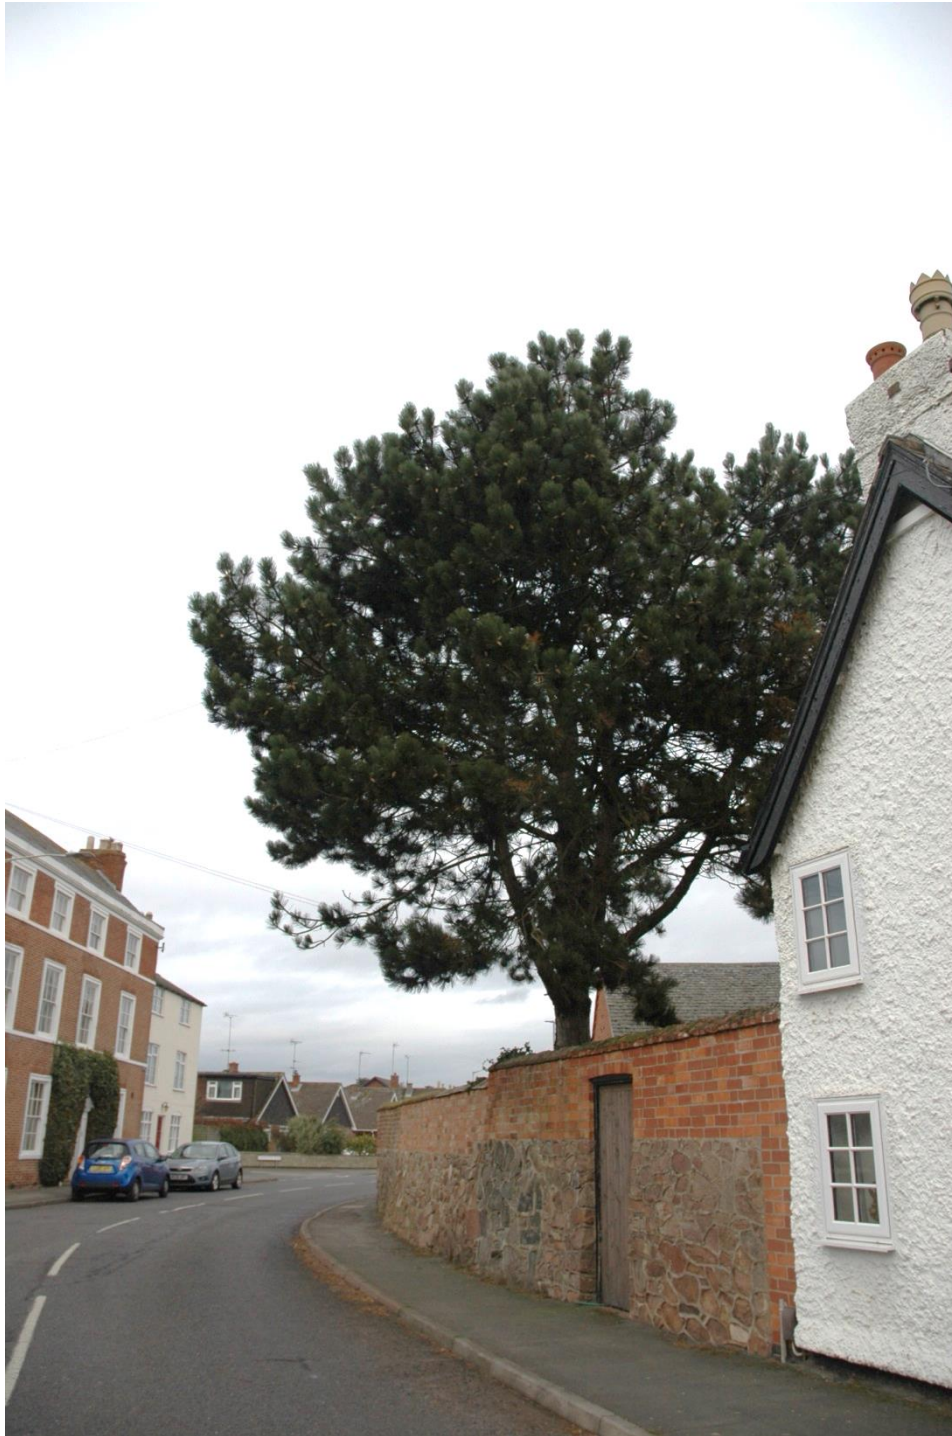
This image shows the natural overhang of the highway. I would recommend minor crown lifting to ensure 5.2m clearance as required by the LCC Highways

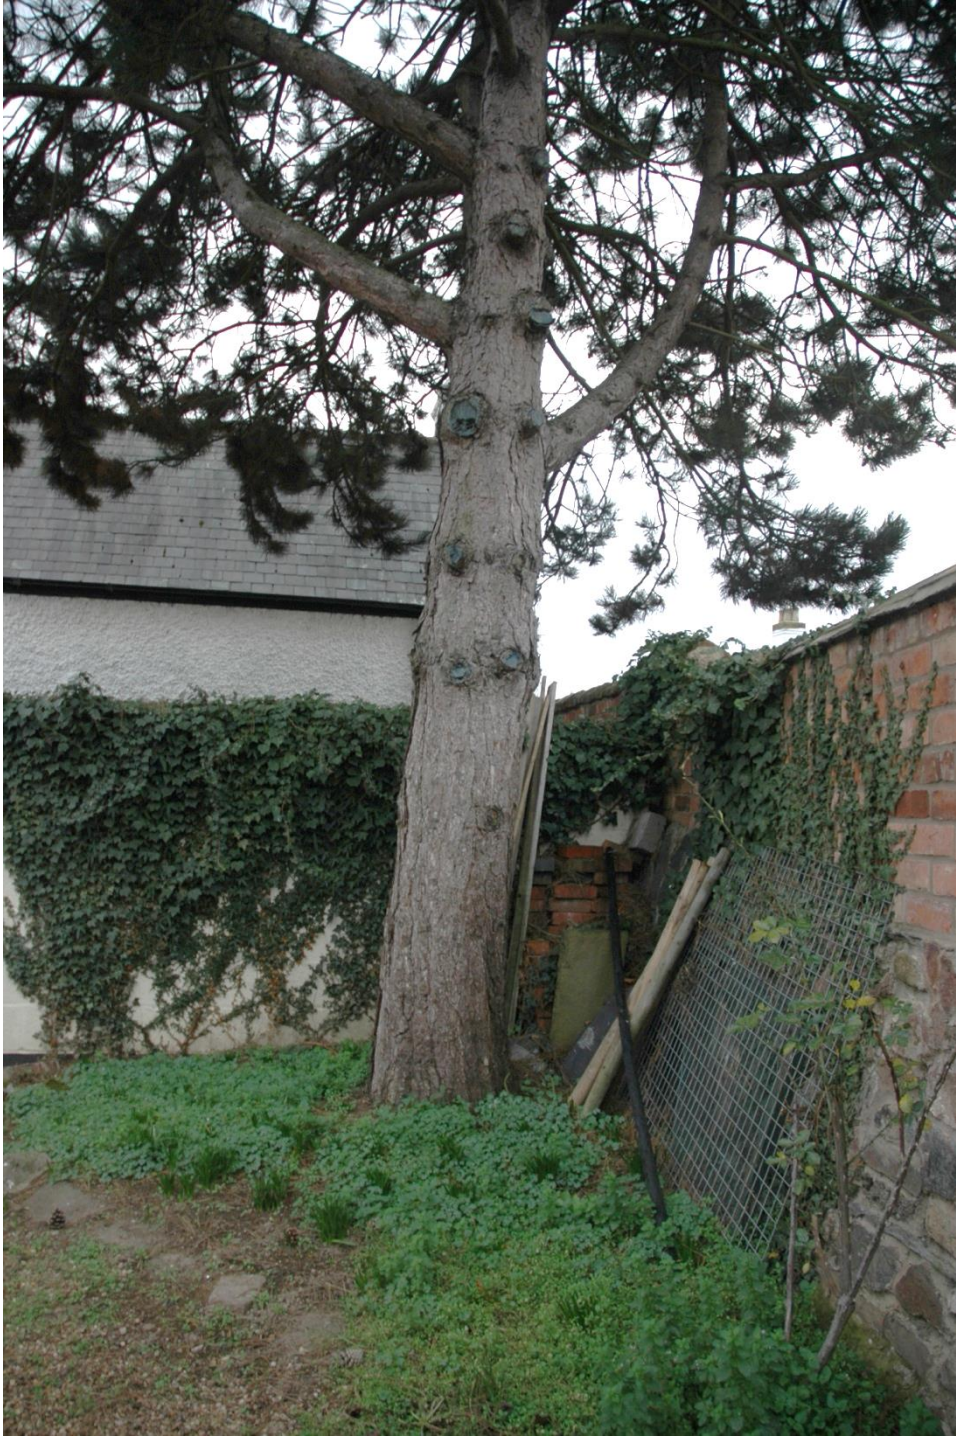
This image shows that the tree trunk is not touching the wall.
