**APPEALS AND REVIEW COMMITTEE 08 June 2020****BOROUGH OF CHARNWOOD (LADY JANE PARK, BRADGATE ROAD, NEWTOWN LINFORD) TREE PRESERVATION ORDER 2019 - PROVISIONAL****1.0 Introduction****1.1 Background**

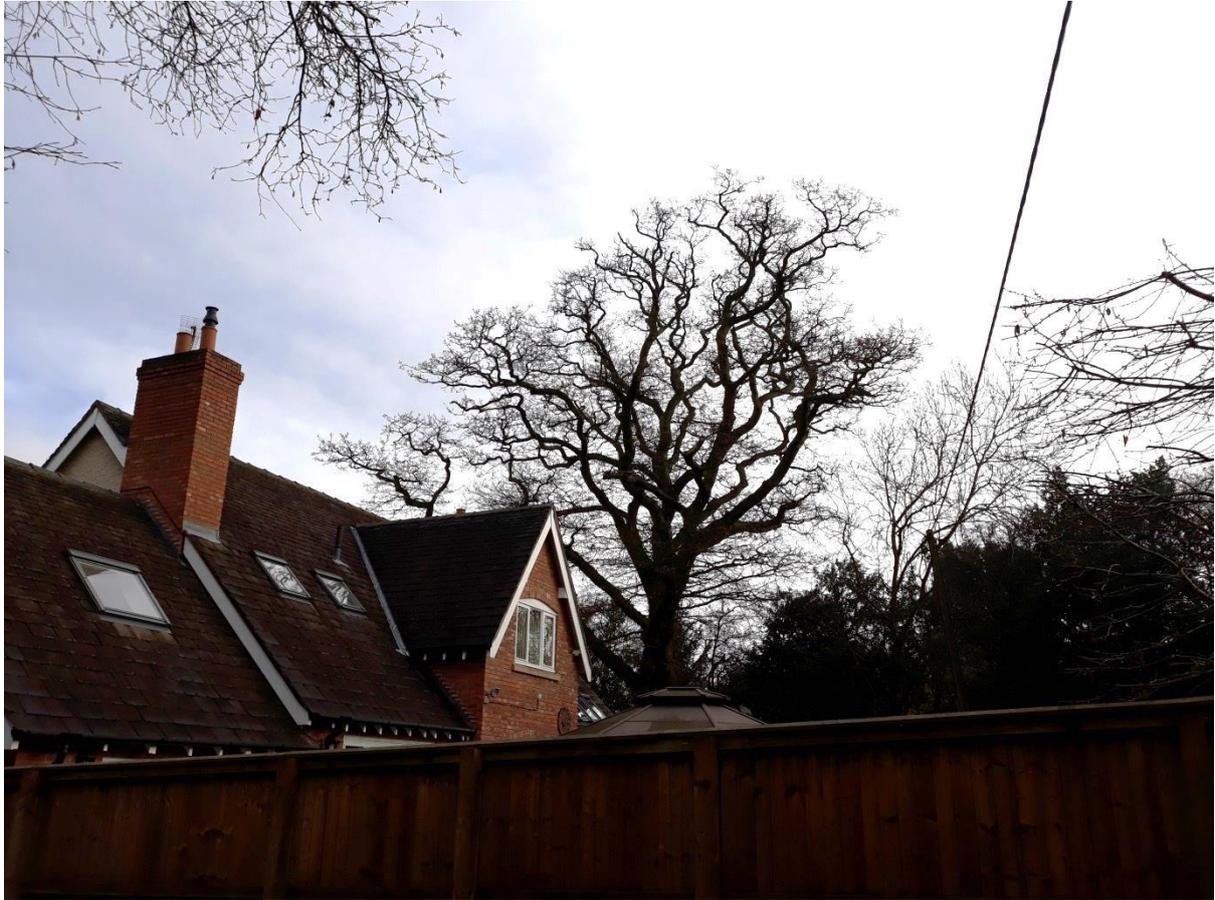
The tree referenced in the S211 Notice is identified in the above planning application tree survey as a mature tall established oak T1, of notable girth and classed as a category A2 tree. The tree is described as of moderate condition displaying good vitality though the presence of a bracket fungus is noted in the buttress region. The survey notes that there have been numerous branch reductions which have left large wounds. The application survey erroneously used the now defunct 'DBH' (DBH means diameter at breast height, notionally regarded 1.2m. This is now replaced by 1.5m.) Notwithstanding a stem diameter of 1.5m was recorded. This should give a girth measure in region of 4.0-4.7m approx. range strongly suggesting the tree is a veteran if not ancient. The recommended management for a tree with this type of fungus is to remove any dieback back to healthy live growth and monitor.

Crown reduction is only recommended if extensive decay cavities are found. None have been reported. It is reasonable to conclude that the tree has been over-pruned in the past and badly managed considering its local importance. It is important to ensure that from this point onward it is properly managed.

T1 oak as seen from Stanford Rise

trees amenity value and wellbeing. The committee is therefore recommended to confirm the Order without modification.

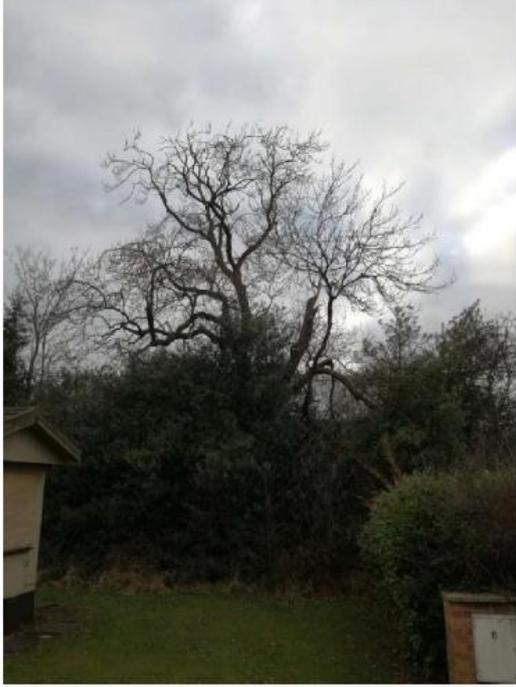
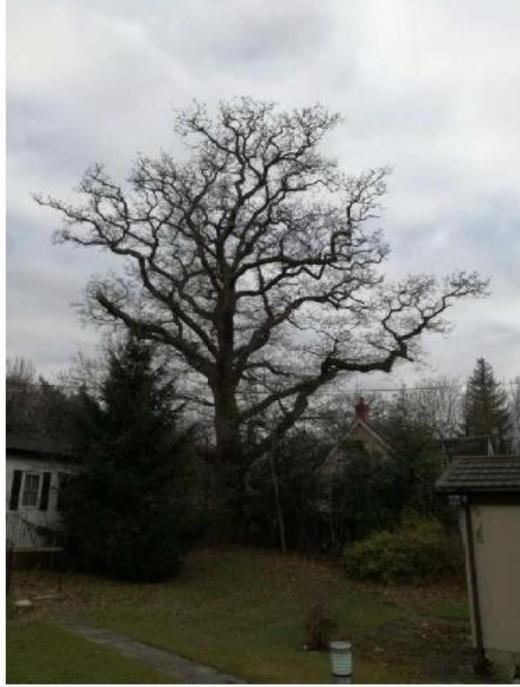
### 5.3.1 Tree T1

Tree T1 is located on the Survey Site boundary and is a tall, fully mature and established pedunculate oak (*Quercus robur*) with a stem circumference of nearly 5m. The tree is likely to be approximately 150 years old.

T1 appeared to display good vitality although several brackets of the wood-decaying fungi, likely to be *Pseudoinotus dryadeus*, were identified in the buttress regions of the stem - the brackets had died back and were corky in texture.

The lower to middle portions of the crown and some regions of the upper crown have been subject to numerous branch reduction works. Several large pruning wounds/stubs with bark tears were identified on the lower stem. These wounds had partially occluded and exposed case-hardened wood was present as well as some regions of softer, decaying wood - there was no obvious evidence of cavities at the time of survey.

Overall, T1 was identified as being in moderate condition at the time of survey.
