129 Rothley Road, Mountsorrel
Tree Preservation Order Assessment

Client: Mrs N Baksa
12th January 2021 – Issue 1
Ref: GL1479

Report Issue 1: 12/01/2021

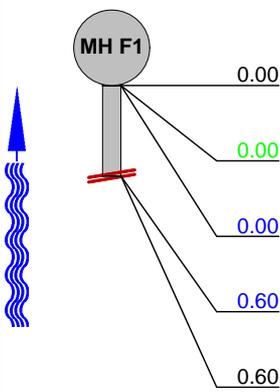
Mh F1 was found to be full of roots ,debris ,failing brick work and damaged benching
 The roots and debris were removed from MH F1 to carry out the survey (as per picture)
 MH F1 upstream has mass roots
 MH F1 A to gully has several displaced joints
 Mh F1 B to svp has several displaced joints
 Mh F1 to main has several displaced joints and root ingress
