APPEALS AND REVIEWS COMMITTEE 11TH SEPTEMBER 2019

ITEM 5 BOROUGH OF CHARNWOOD (2 AND 6 MILL HILL LEYS, WYMESWOLD) TREE PRESERVATION ORDER 2019

Town and Country Planning Act 1990
The Borough of Charnwood (2 and 6 Mill Hill Leys, Wymeswold)
Tree Preservation Order 2019

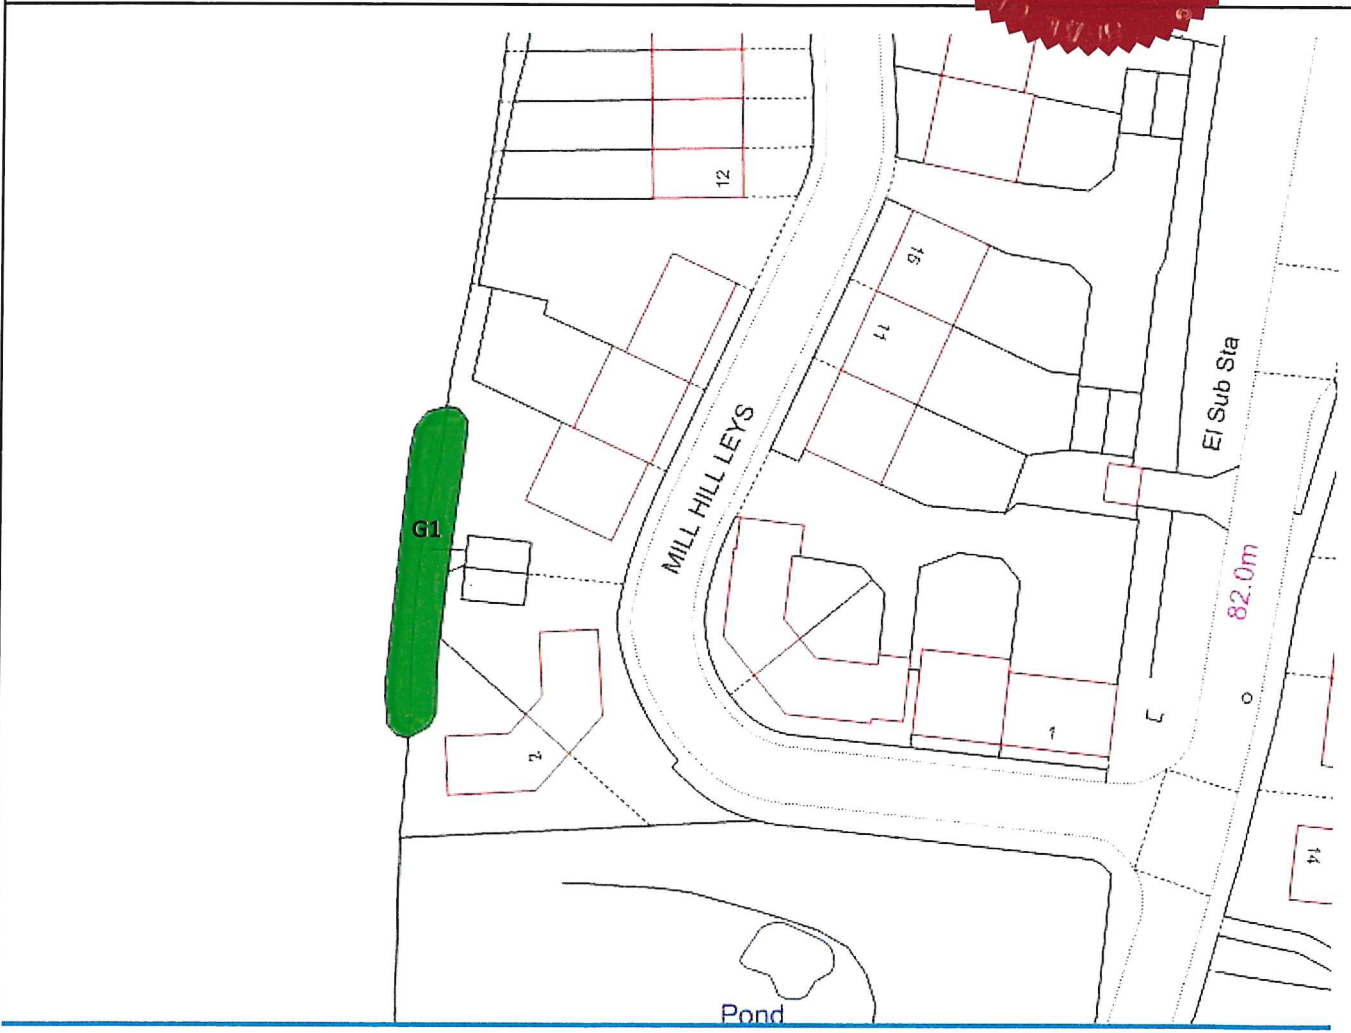
**Borough of Charnwood
(2 and 6 Mill Hill Leys Wymeswold)
Tree Preservation Order 2019**

Reference on map	Description (including number of trees in the group)	Situation
G1	3 ash trees	Grid reference SK60336 23682

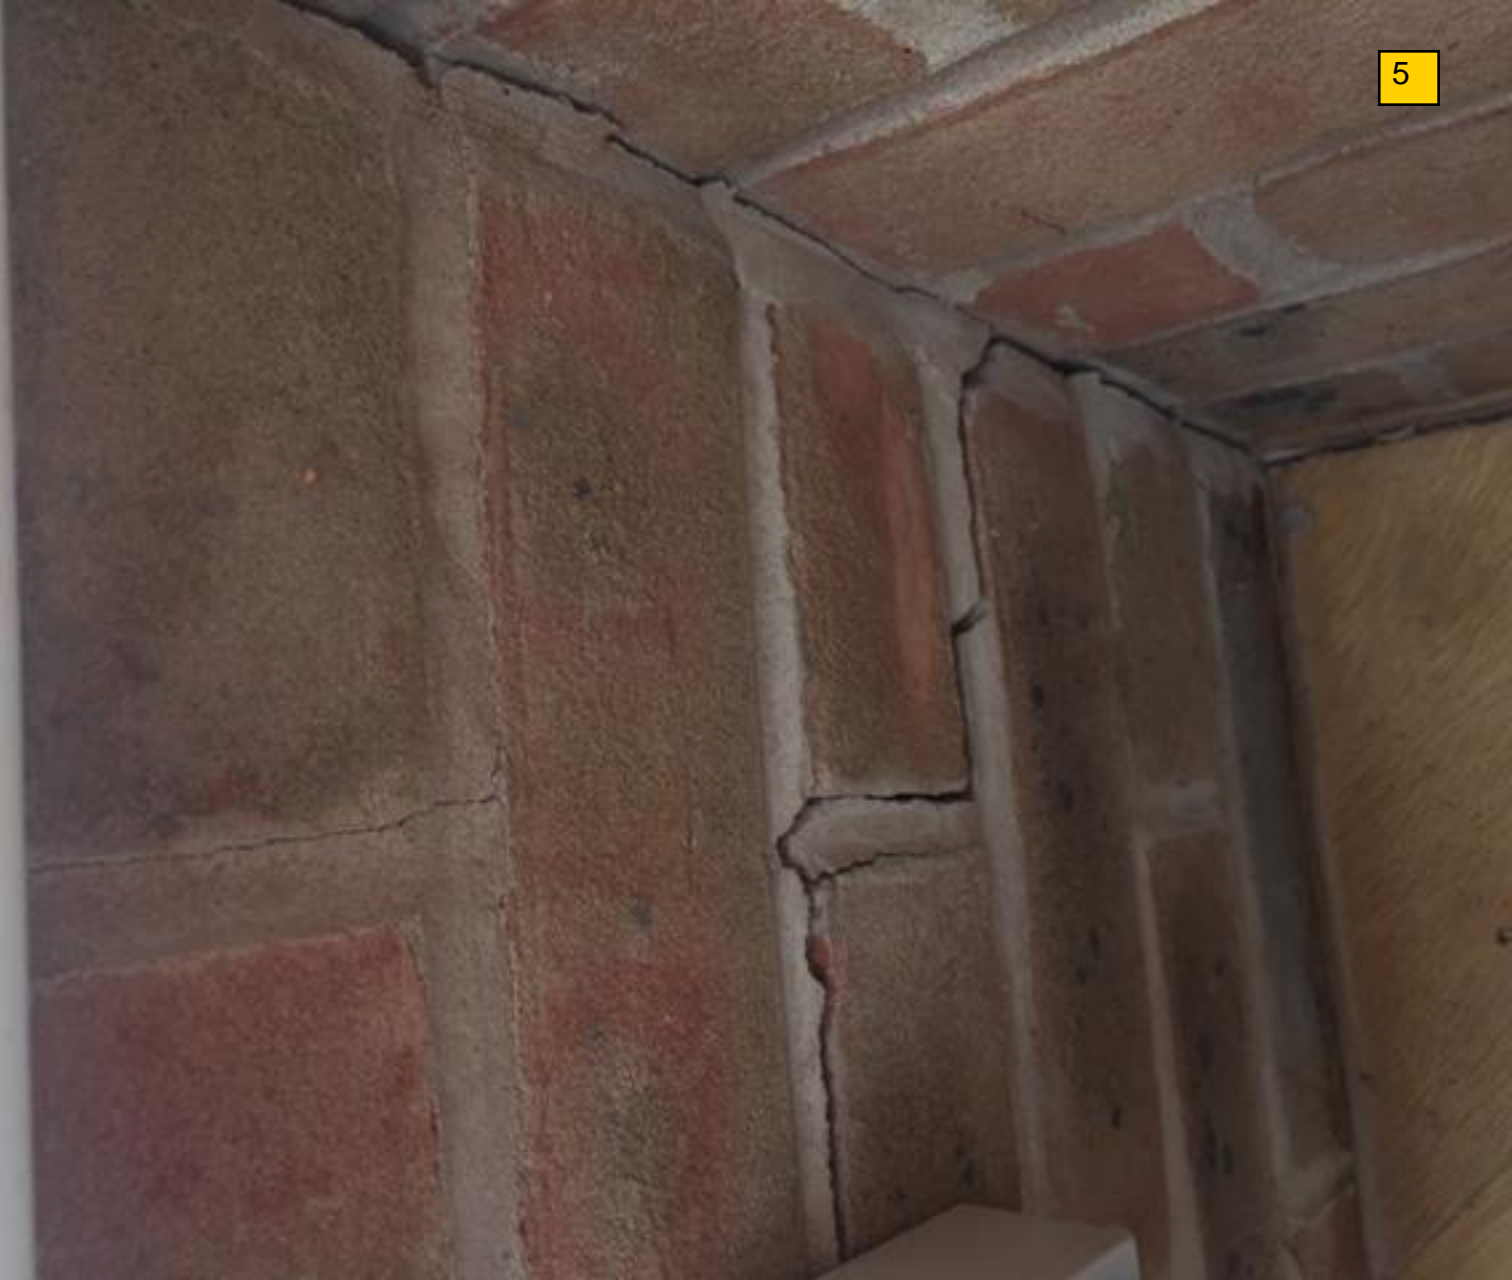
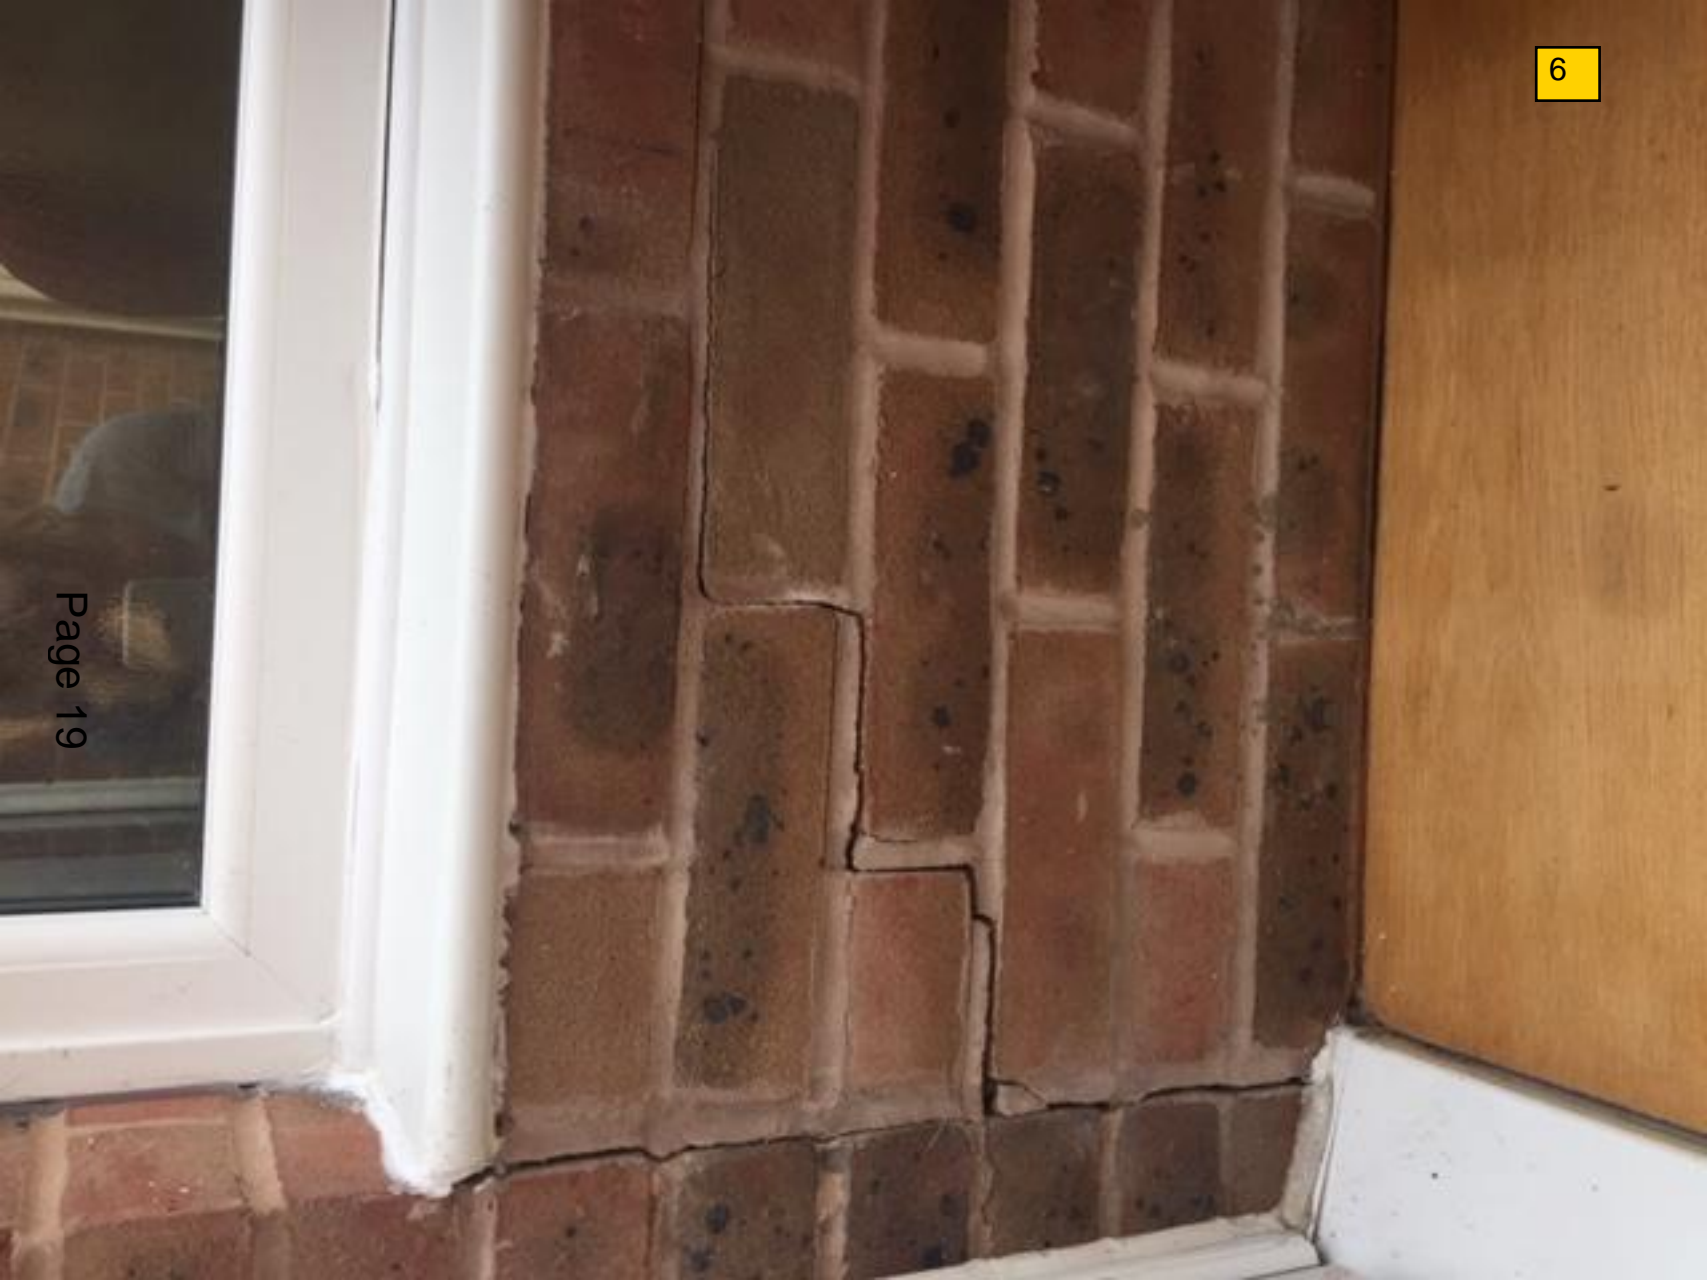
We were particularly distressed to discover this summer that our house now has subsidence issues. Our conservatory now has subsidence issues on both sides of the walls (**pictures five and six attached**). We have now been put to considerable expense and distress in engaging a solicitor (Richard Bates, Rothera and Sharpe) and a building surveyor to take court action to recover our loss in an action of negligence. The large group of trees is considered to be the cause. The deeds to all of the properties contain a covenant that no homeowner can restrict, or allow any matter to restrict, the enjoyment of a neighbouring property. We remain (as does our insurer) exceptionally concerned that our home and garage will be subject to further damage whilst the height, roots and proximity of the trees remain as they are.

The main area of damage affects the Conservatory and takes the form of Stepped diagonal cracking affecting sub-structure/super-structure brickwork accompanied by slope of window heads/sillss towards the rear.

The level of damage is moderate, and is classified as category 3 in accordance with BRE Digest 251 - Assessment of damage in low-rise buildings.

When considering the evidence obtained from our visual inspection and appraisal and the subsequent ground investigation it is my considered opinion that the cause of damage to the Conservatory is the result of clay shrinkage subsidence exacerbated by the water demands of nearby vegetation, in this case the Ash tree(s) located beyond the rear boundary of the property.

Following successful tree mitigation work and a period to allow for soil recovery sub-structure and superstructure repairs to brickwork can be carried out. In conjunction with this work it is likely that realignment of distortions to window and door openings will be necessary.

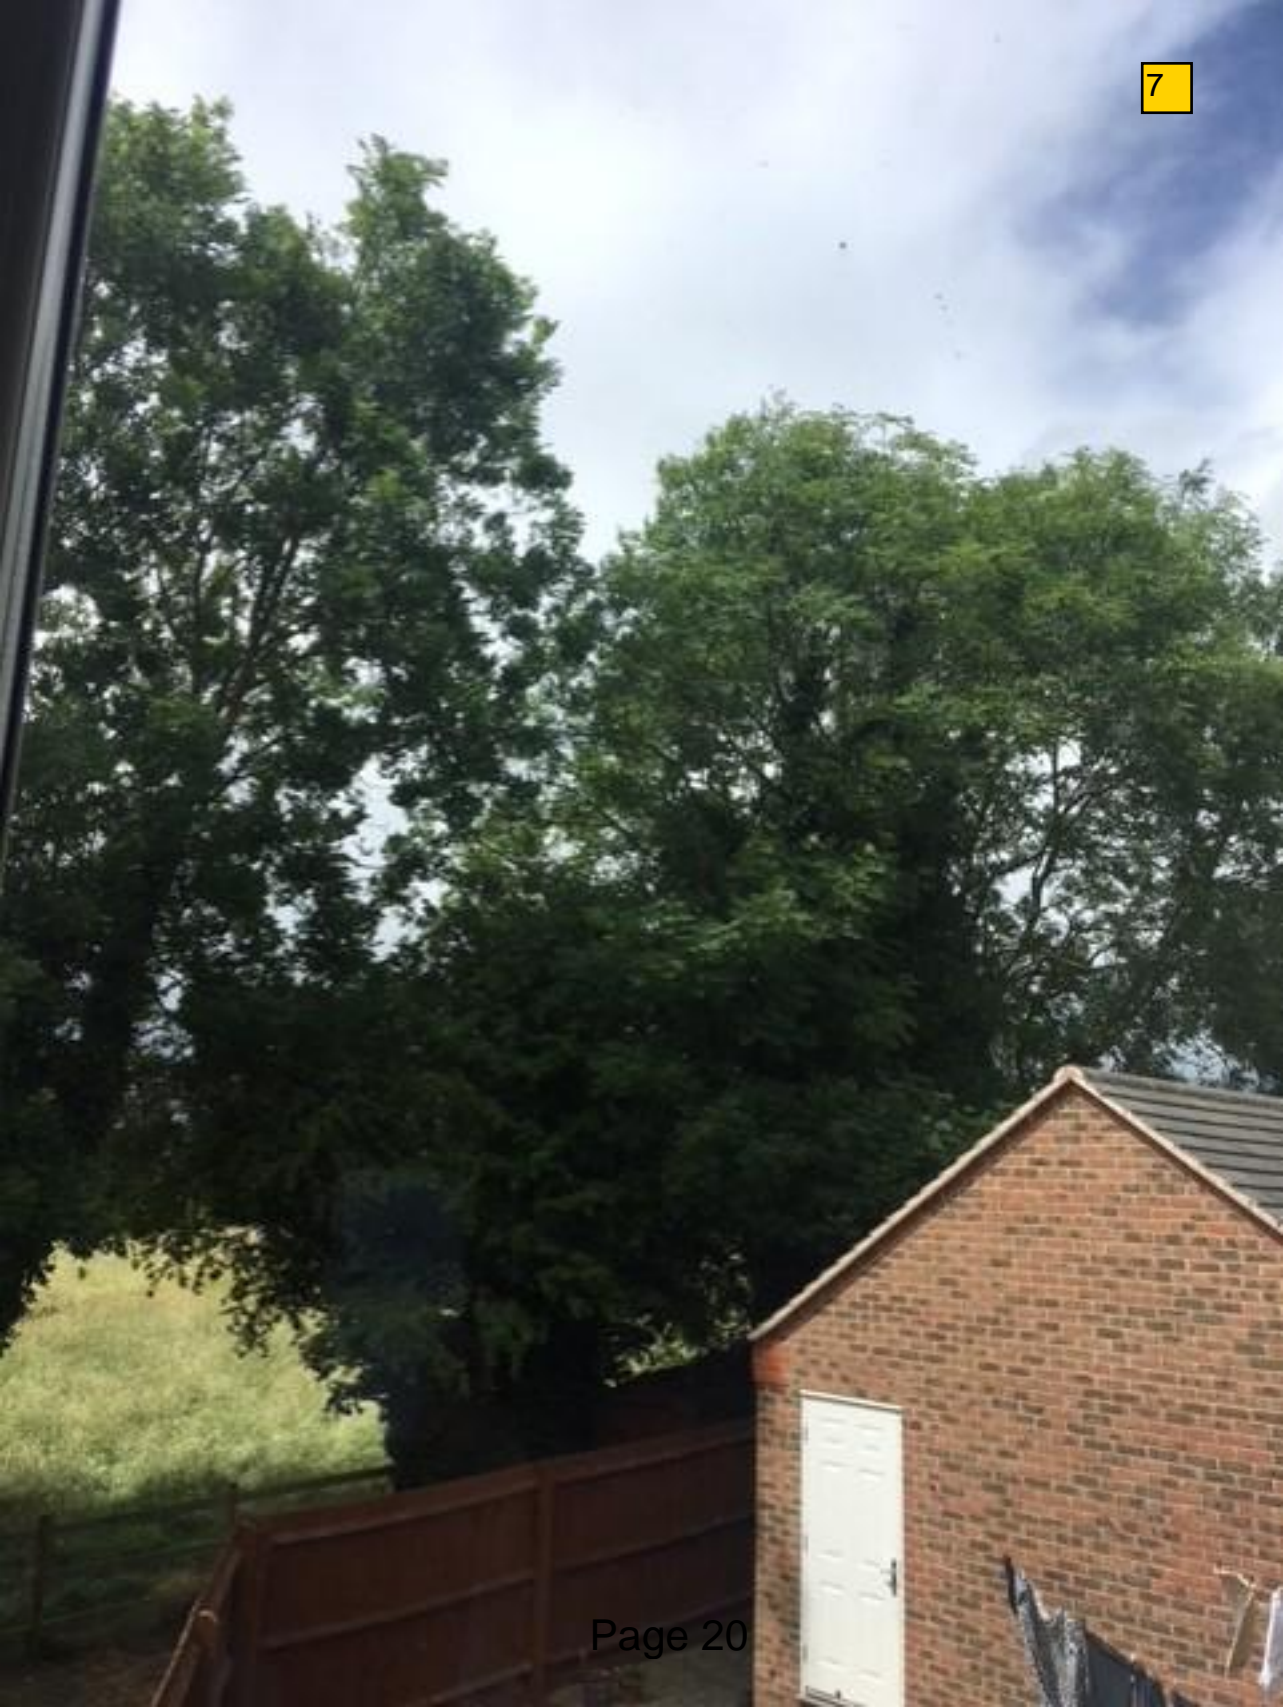
The owner of number 2 Mill Hill Leys allowed the branches of their tree behind the garage to grow over our property and rest on our garage roof (**picture seven enclosed**). Despite frequent requests for this to be cut back we were forced to procure this work ourselves at considerable cost as the roof was being damaged by the weight of the branches resting on the tiled roof.

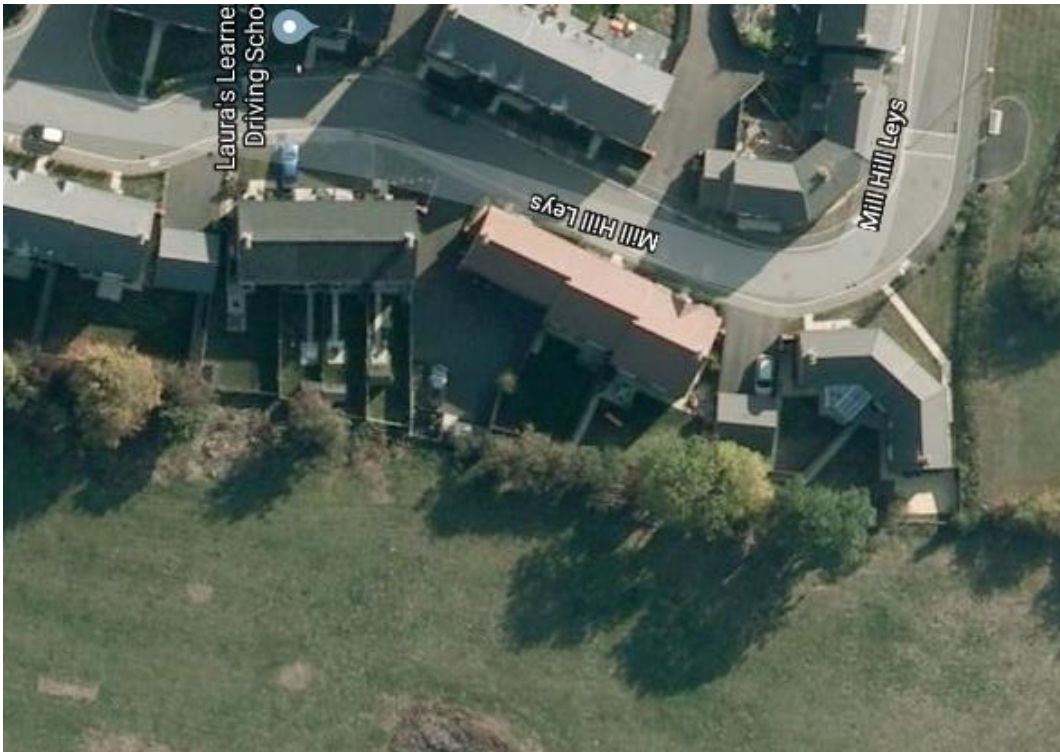
- 1) Aerial image showing the rear of properties along Mill Hill Leys. Group G1 is circled in red.

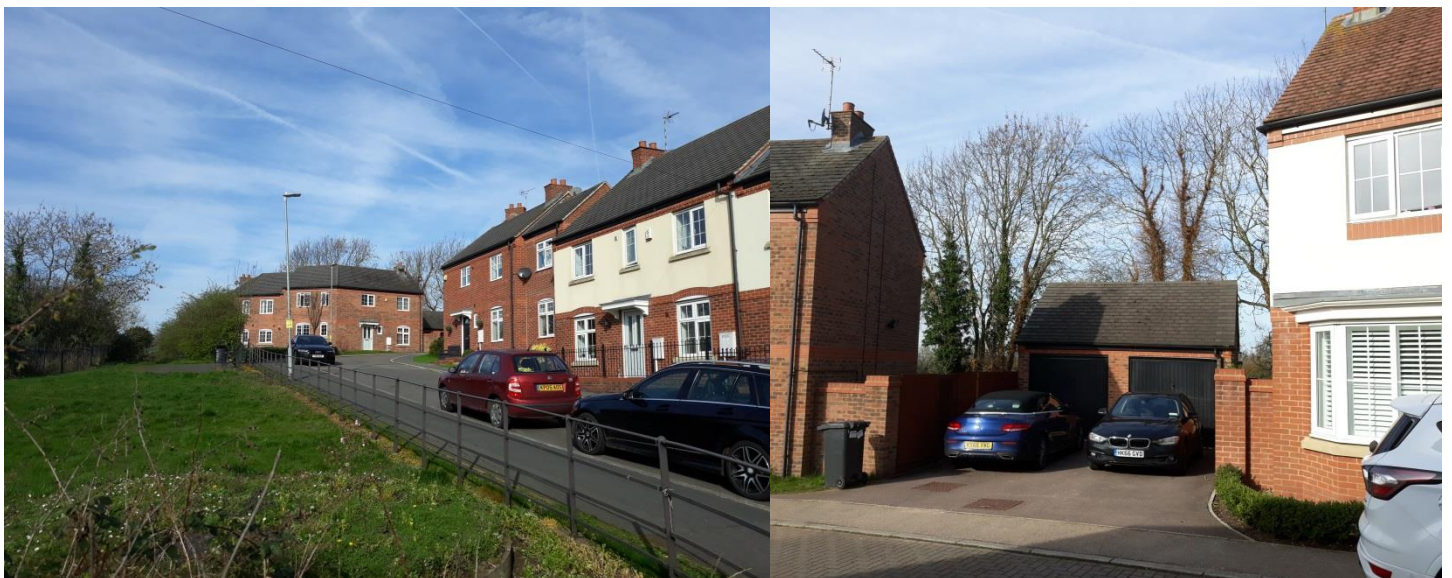
- 2) View of the tree group (G1) from Mill Hill Leys

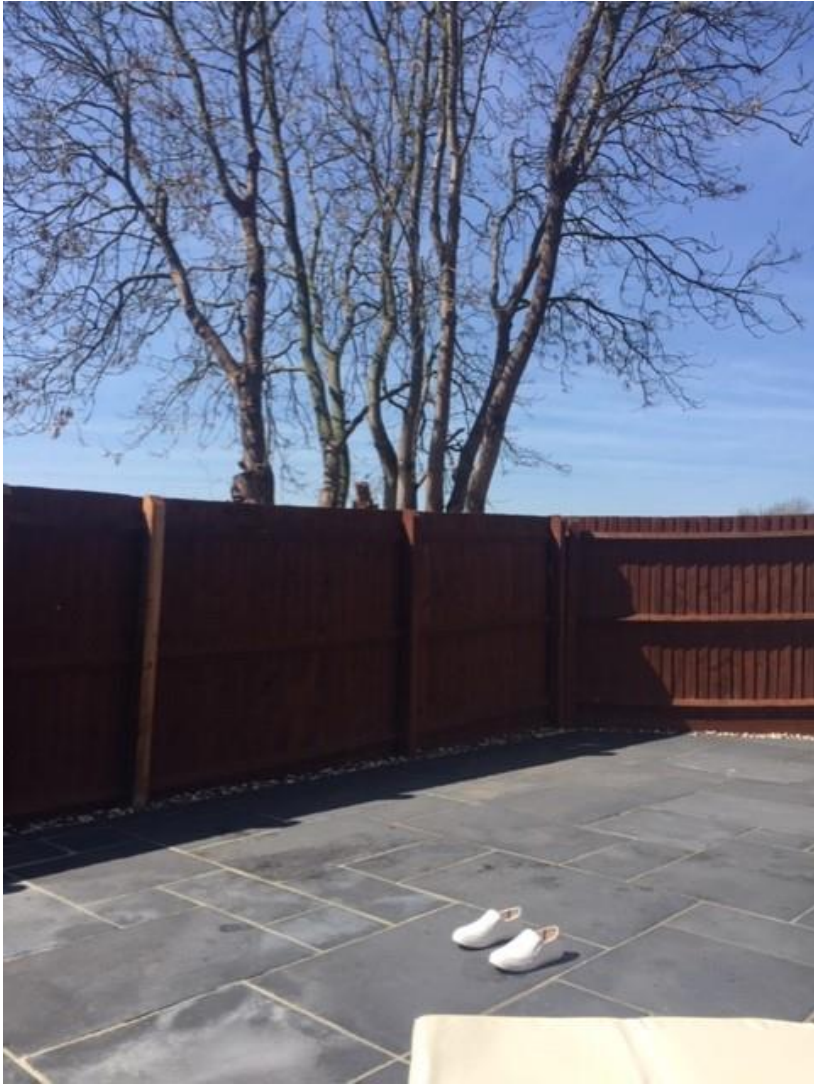
3) Garden of number 4 Mill Hill Leys

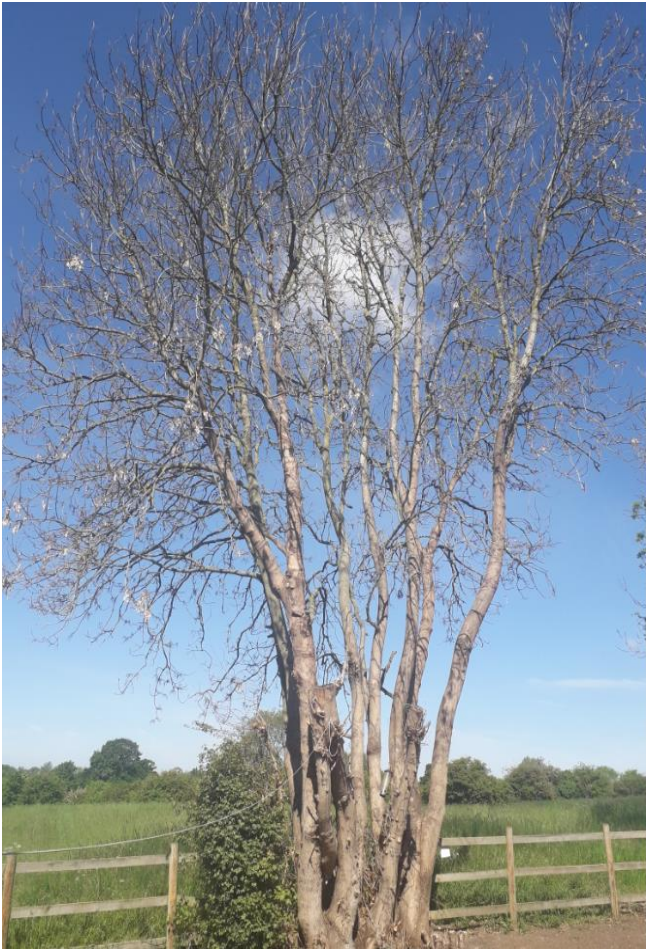
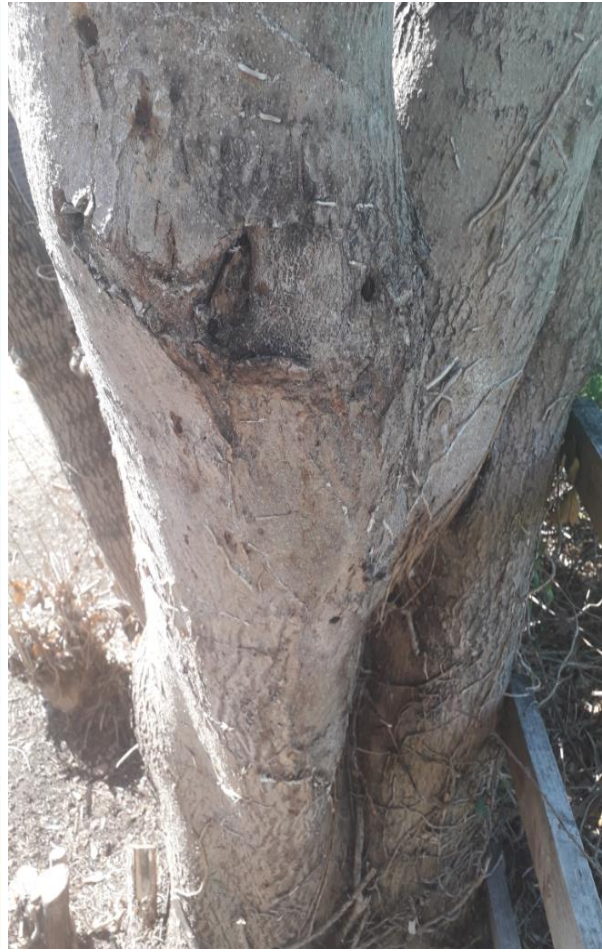
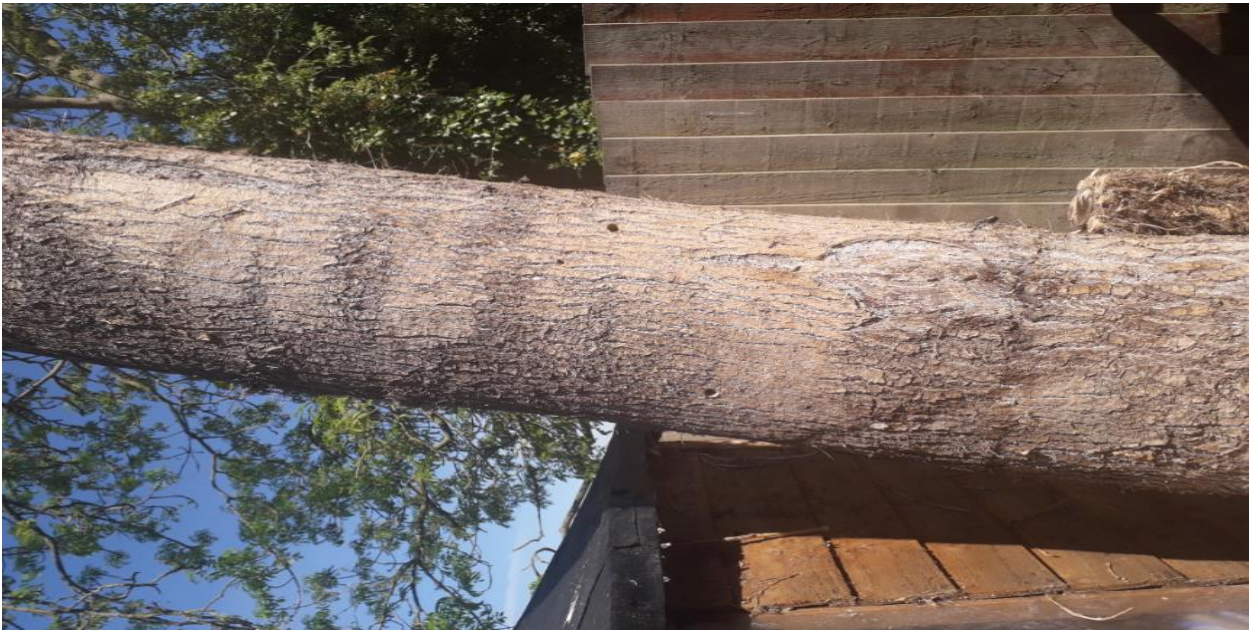
Following the issuing of the provisional order a request was made for a further site visit on 28th May. On arrival at the site it was observed that the two ash trees (forming part of group G1) to the rear of 2 Mill Hill Leys were both dead. The trunks of these trees had several neatly formed and equally sized holes sloping down into the trunk at around chest height and below. The light coloured appearance, size and smooth, even sides of the holes indicated that they had been drilled recently. There was a patch of dead grass around the base of the tree extending for approximately 1.5m from the trunk. These signs were considered to be a strong indication that the trees had been poisoned.

Appendix 2 Photographs of dead trees taken in late May
