Illustration of the proposed bungalows as a photomontage with the church and frontage.

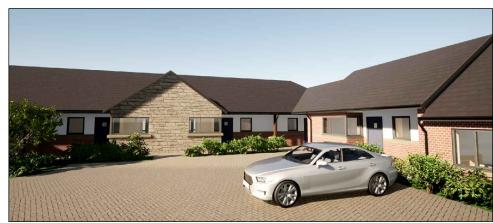
Courtyard views - corner windows to kitchens & covered charge areas for mobility scooters by the front doors.

- Corner windows in the kitchens allow the residents better connections with the outside to reduce loneliness & enhance interaction with visitors.
- Materials mix brick, render and recon stone. Recon stone was introduced to help the scheme fit with the church next door. We wanted the scheme to appear as though it could be a set of contemporary "Almshouses" to give it a recognizable character.
- Plenty of parking with level access to bungalows.
- Bin stores are turned into gateway elements to make the car park more private. We wanted to try and stop people thinking it was a public parking area.
- The hedge to Melton Road is thickened with a mix of hedge plants and a replacement tree for the one lost to the frontage.

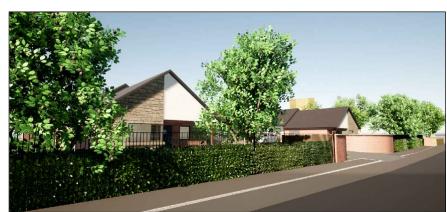
View along frontage to Melton Road.

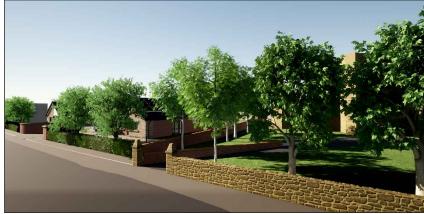
View from the front of the church to show the low impact of the bungalows.
